The Refit of a Classic Cheoy Lee 41

Refit and Restoration: Phase I

Svendsen's Boat Works, Alameda, Ca.

Mast Rebuild, Re-Rigging, New Sails, and other Safety Work

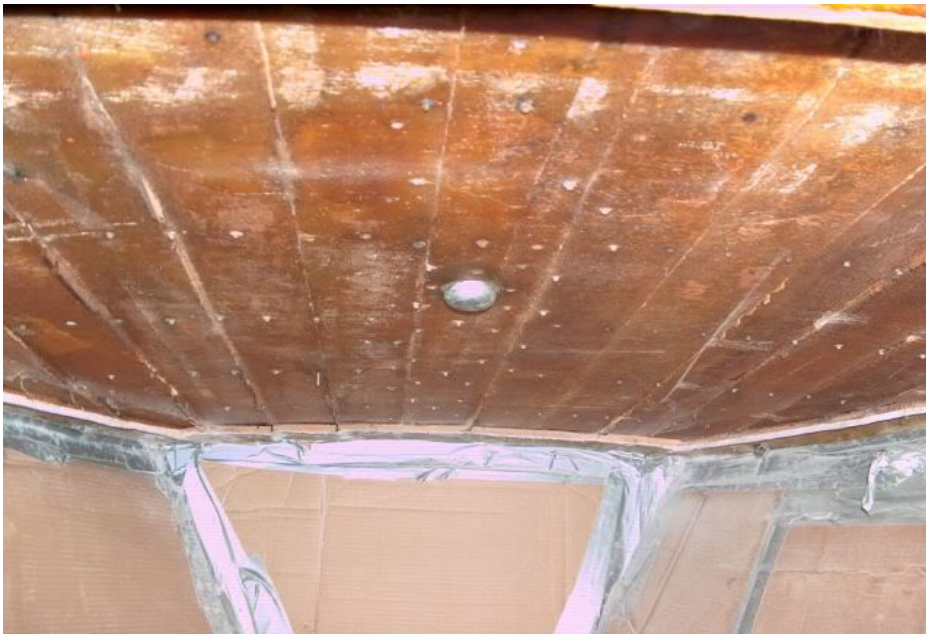
Rather than damage the Teak decks topside, the Svendsen's fiberglass shop came up with the idea of removing the interior layer of fiberglass. (Smart!!!). They found that the rough sawn Teak core had no water damage, no sign of water leaks, but had come delaminated from the upper and lower layers of fiberglass. The oily nature of Teak does not make it a good coring material. I am surprised Cheoy Lee used the Teak rather than some other wood such as mahogany.

Anyway, here we see the lower fiberglass layer and the teak core removed. This looks like wood, but the Teak core is gone. What we see here is the bottom side of the upper layer of fiberglass decking. The now removed Teak had given the fiberglass a wood grain appearance. The boatyard then fabricated a new core of balsa, laminated the balsa to the upper layer of teak, and then layed a new interior layer of fiberglass. The result was a firm, stiff fore deck and a nice smooth overhead in the V-berth. Now to replace the headliner.

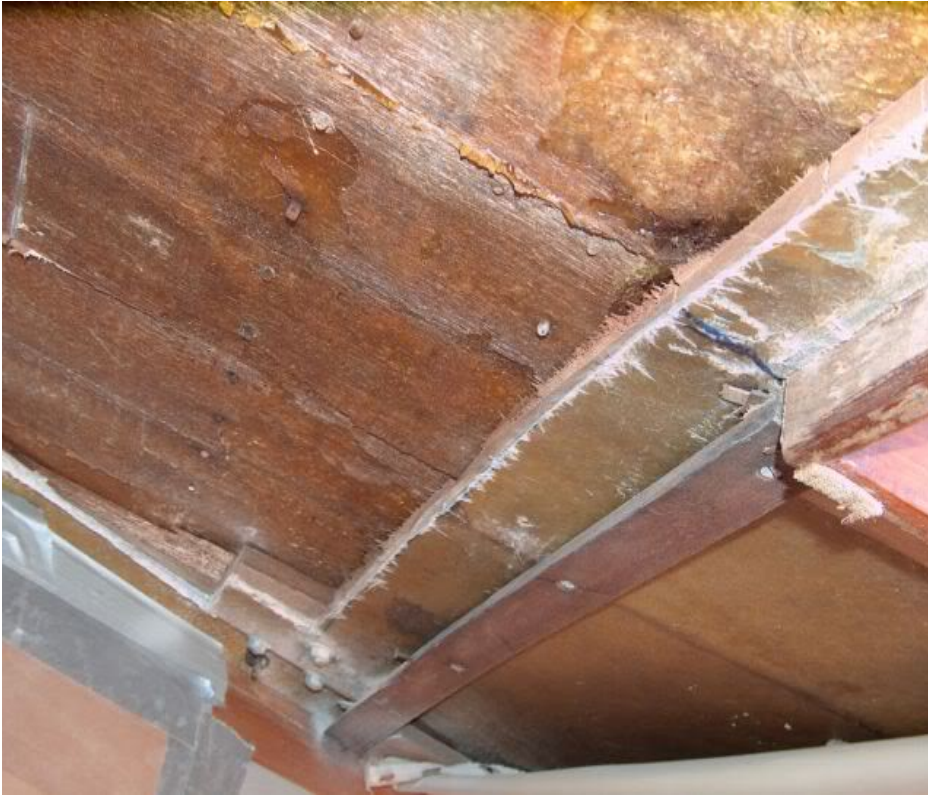
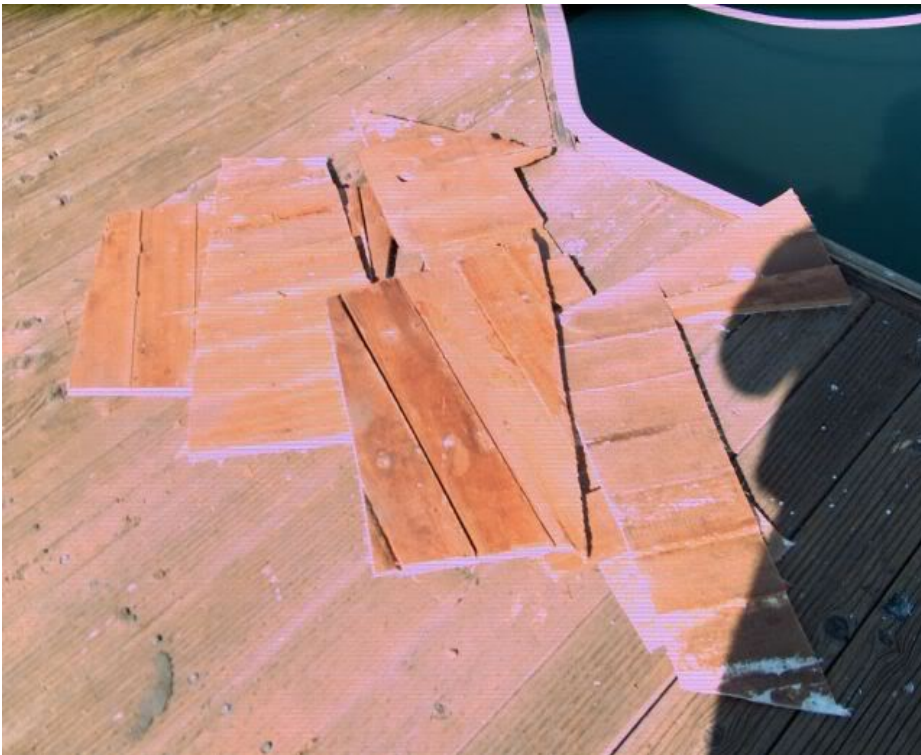
A stack of expensive scrap wood! Teak from the core.

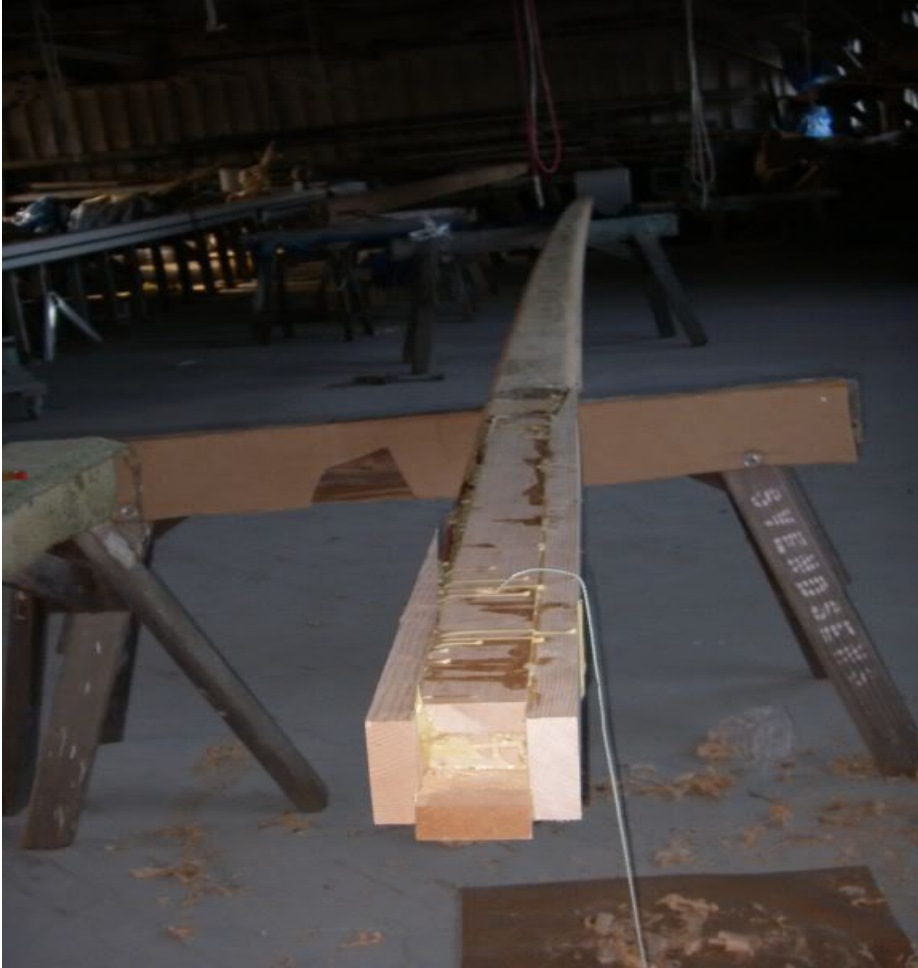
Leaks around a windlass on the mizzen mast had allowed water intrusion, resulting in rot in the bottom four feet of the mizzen.

Therefore the master carpenter at Svendsen's replaced the bottom four feet of the Sitka Spruce. It was quite a job, trimming the old spar, sistering on new wood, gluing, clamping, and then planing and sanding.

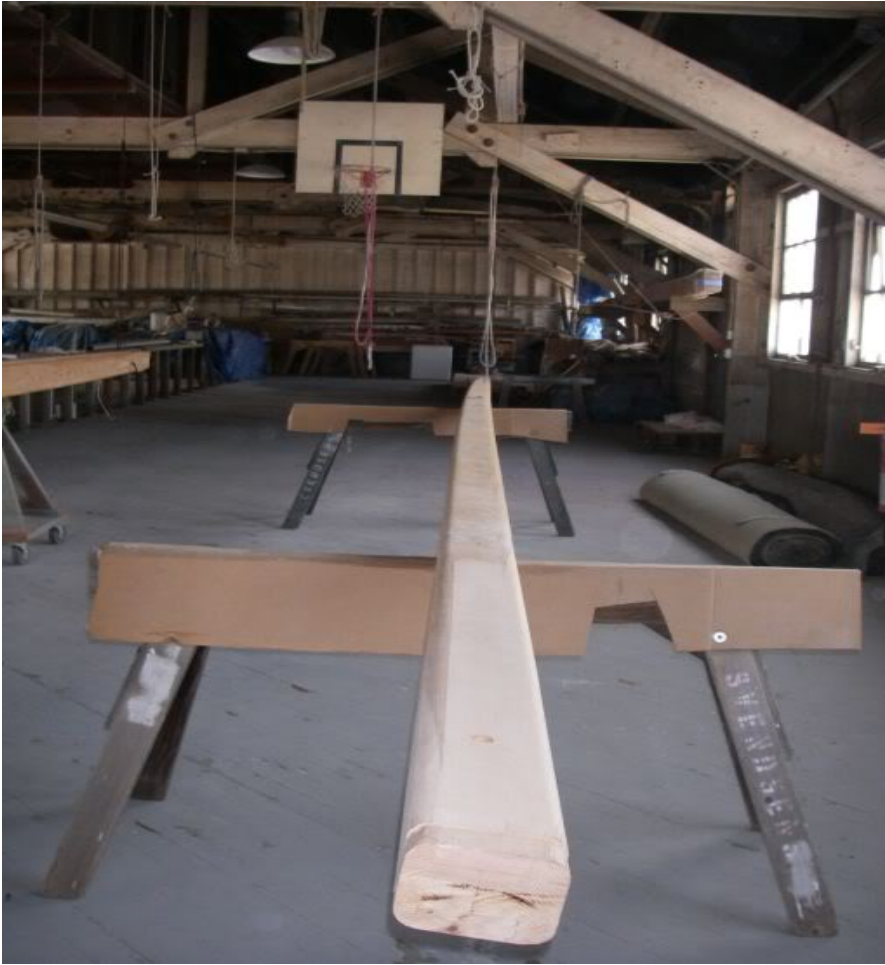
The restored mizzen mast. The bottom four feet is new, but you can't tell by looking. These guys are true craftsmen!

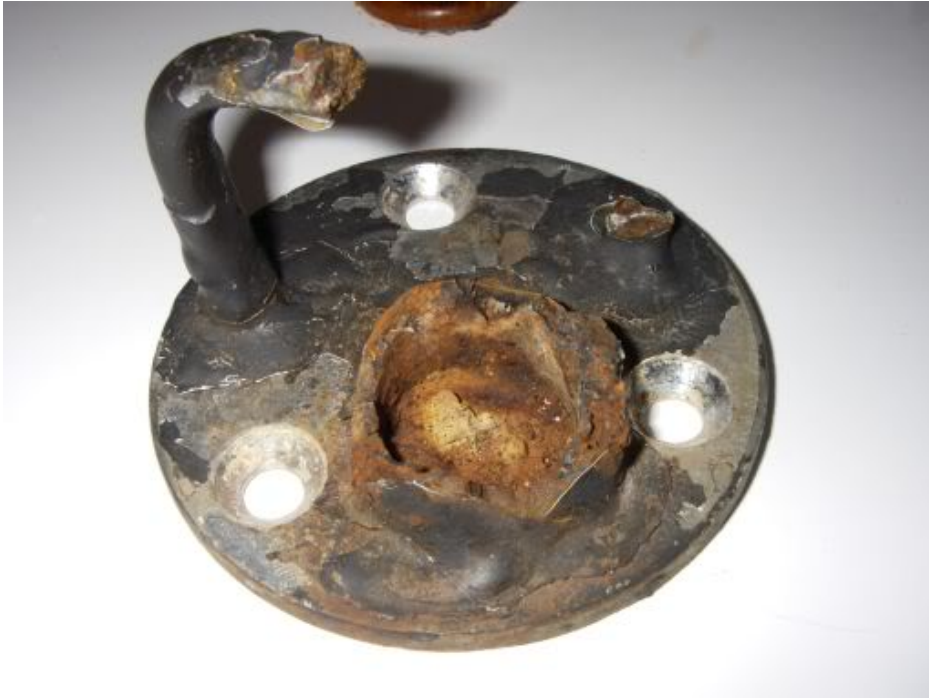
Before:

The old stanchion bases all had to be replaced for safety. They had looked "OK" on the boat, just cracked in places. However we felt it best to go ahead and replace them. Fortunately the stanchion foundations were solid fiberglass and raised above the teak decks. The only problem was it took two boatyard riggers two days (four man days!!!) using impact wrenches and other heavy tools to remove the old stanchion bases. The new stanchion bases. Beautiful!!!

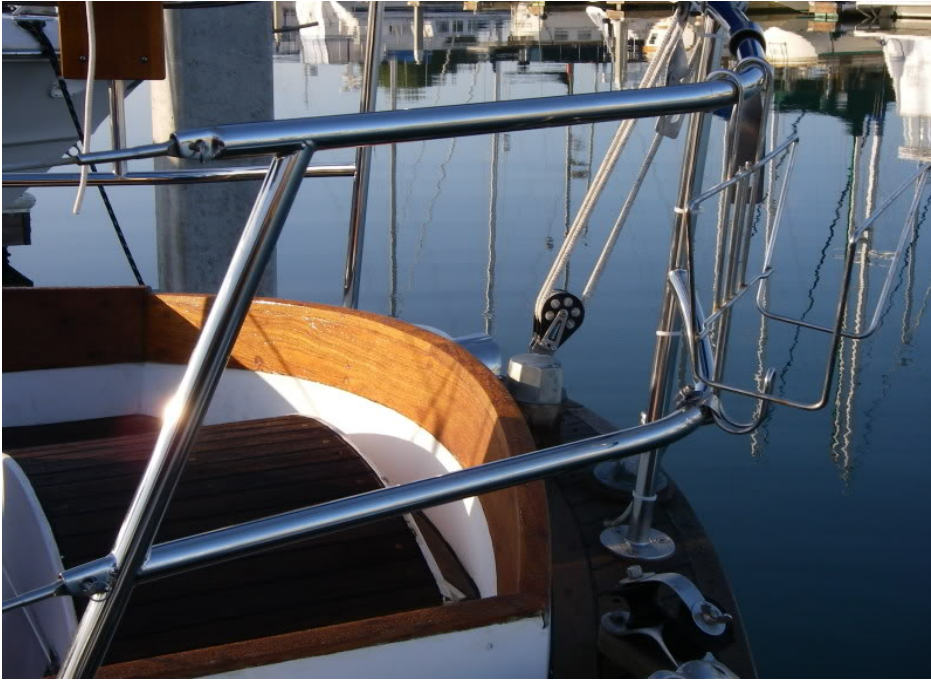
I had recently rammed into a concrete post at our dock and dented in the bow rail, so we had to have a new bow pulpit. Also decided to go ahead and replace the stern pulpit while we were at it. Cheoy Lee had used some sort of klugey t-joints at the connections. Svendsen's replaced them with new custom made units with welded joints. Much improvement. Here are the new ones.
