THE REFIT OF ASTRAEA

The Refit of a Classic Cheoy Lee 41

Phase III Continued

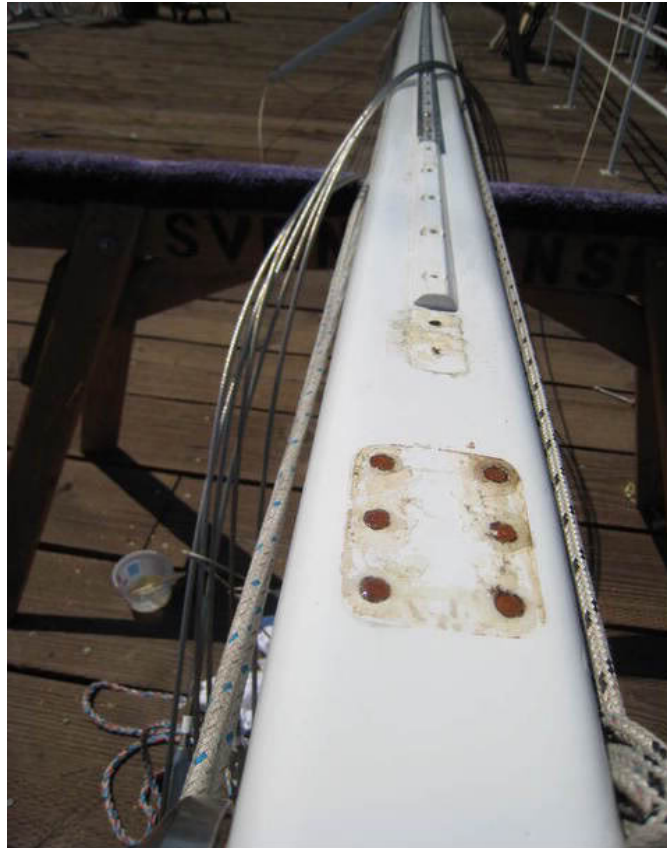
Also, the Mizzen Boom is being raised 14 inches to allow a normal person to stand up at the helm. Not sure why Cheoy Lee mounted that boom so low.

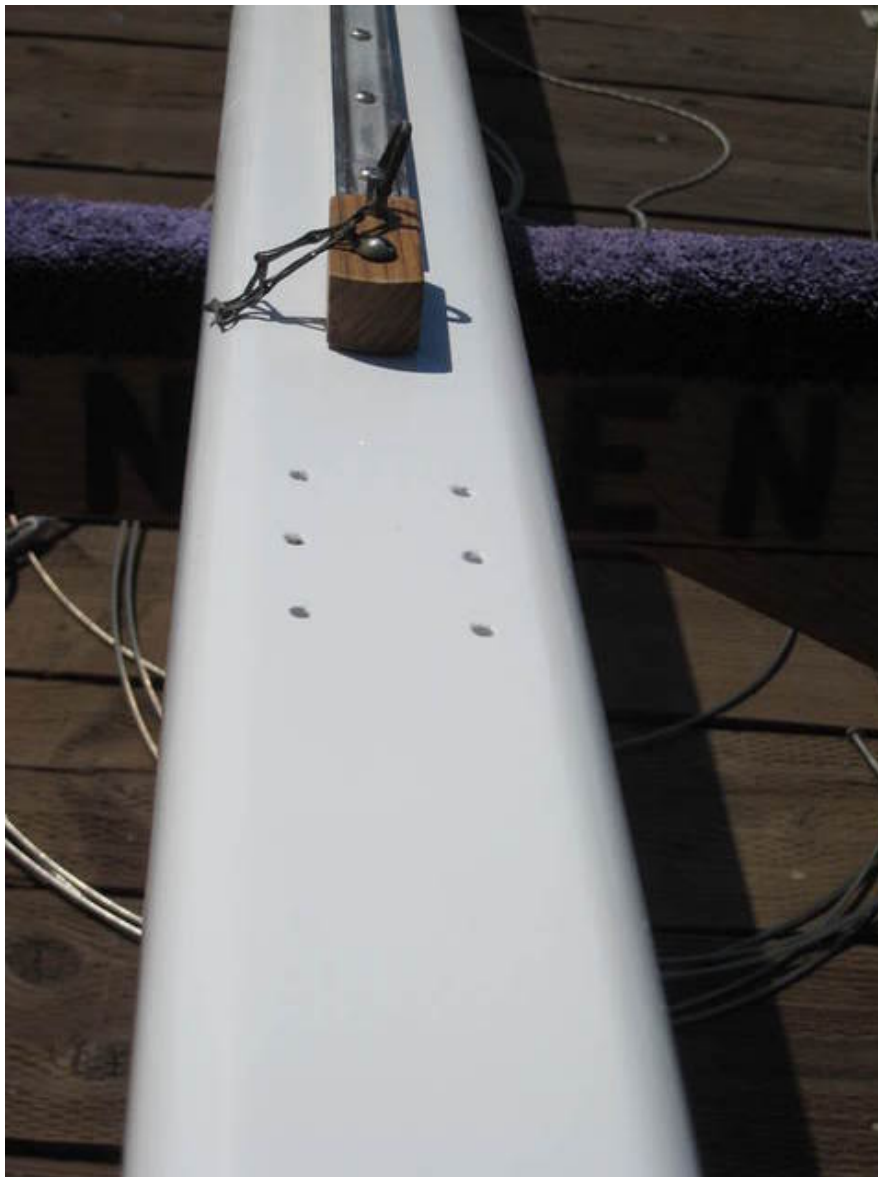
Here is the mizzen after the track was raised and the Awlgrip repaired. It will be great to have the mizzen high enough to stand up underneath it!

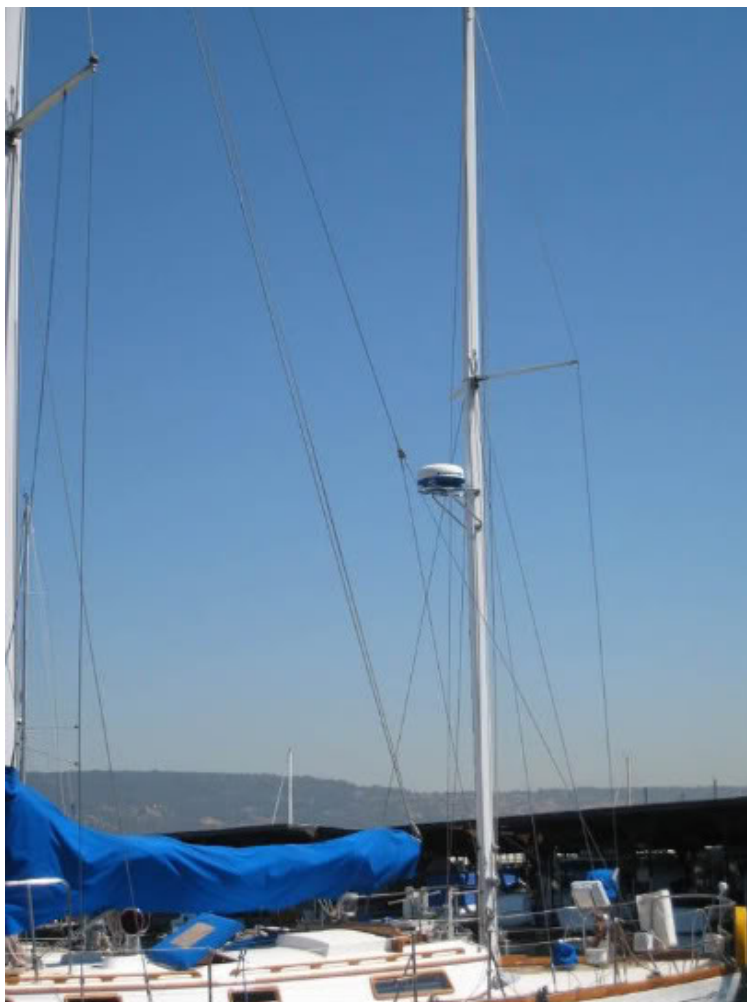
Mizzen back up!!!! This is a huge psychological factor to have both masts back up. The new radome and custom radom mounts are on the mizzen now.

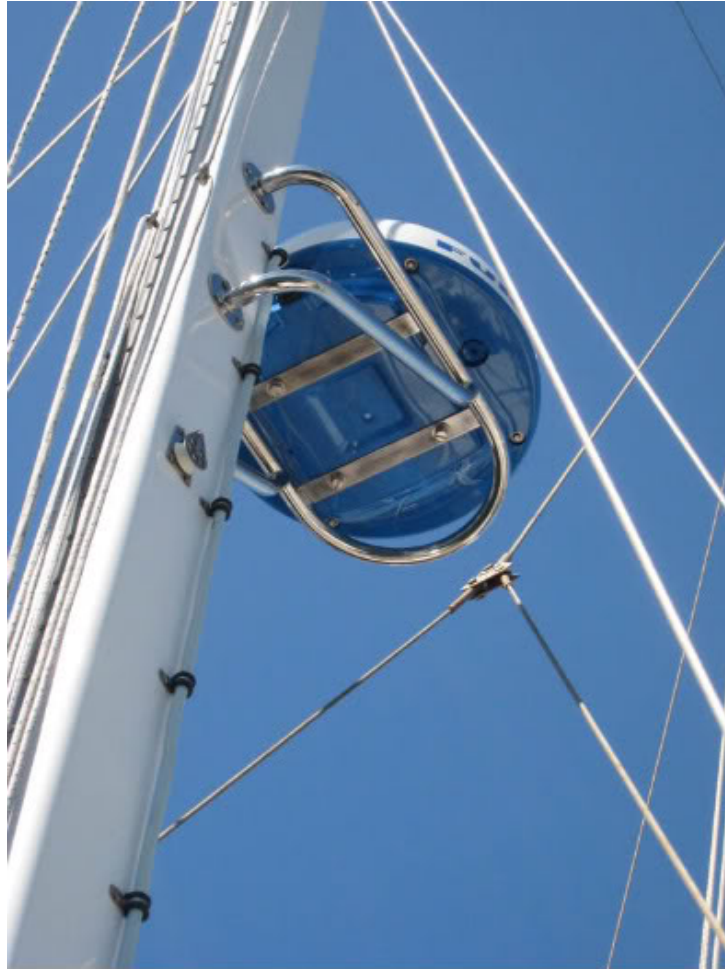
New Furuno radome with custom made radom brackets.

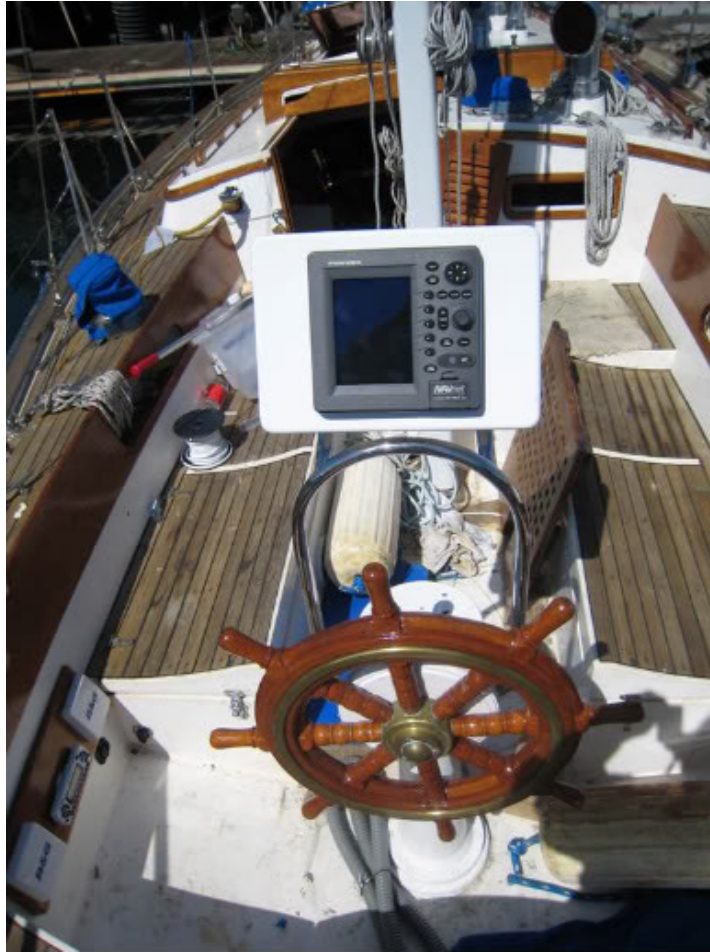
New Furuno NavNet2 repeater at helm. The binnacle is not yet back in place. There will also be a large NavNet2 repeater at the navigation desk inside the boat.

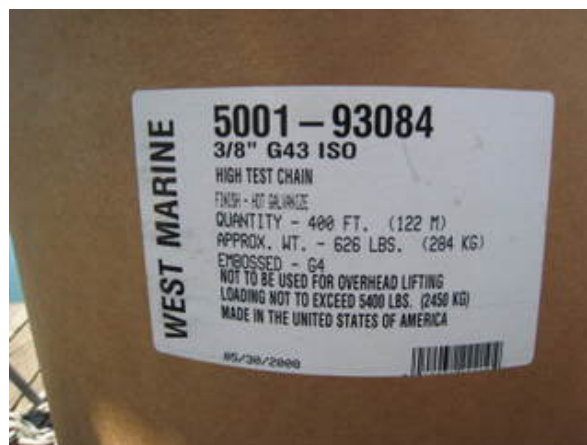
This is the new chain. This has a working load strength of 5400 pounds and a breaking strength of 16,200 pounds. This is almost twice as strong as BBB, and slightly lighter. Good stuff.

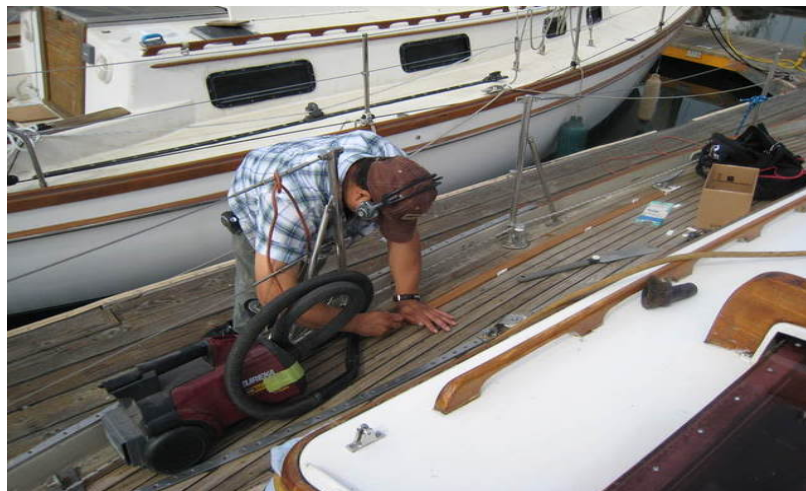
Here a yard worker has removed a damaged piece of teak and is replacing it. Big, big bucks here in San Francisco.

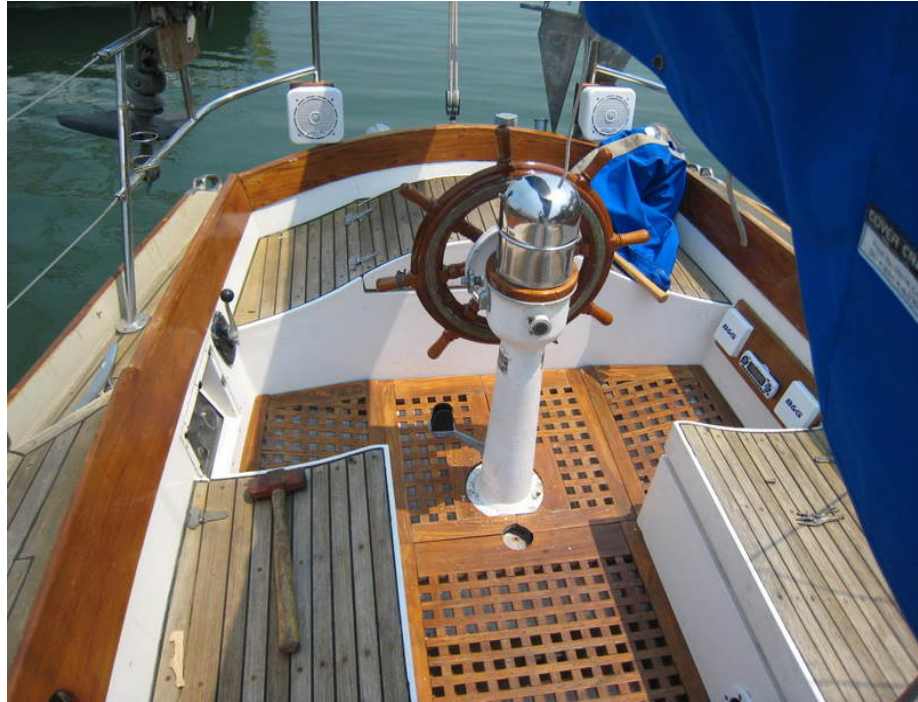
I am taking the opportunity of being the the boatyards to do some work on Astraea myself. The pedestal looked pretty bad and had a number of coats of paint on it. I decided since we are installing a new pedestal guard and new 7" Furuno NavNet2 radar/GPS repeater at the helm that I should ge the pedestal looking better.

Here is the pedestal just after the yards removed the pedestal guard to modify it to hold the NavPod with the Furuno repeater.

I used several layers of paint remover, an electric wire brush, and then 80 grade sandpaper and got it down to the bare aluminum. Nothing is ever easy, or even inexpensive. After I got it down to bare metal (aluminum) I had to put on a cote of Interlux Primewash, then a coat of Epoxy Primecoat. After this will put two to three coats of Epoxy Primecoat, and she should look great!

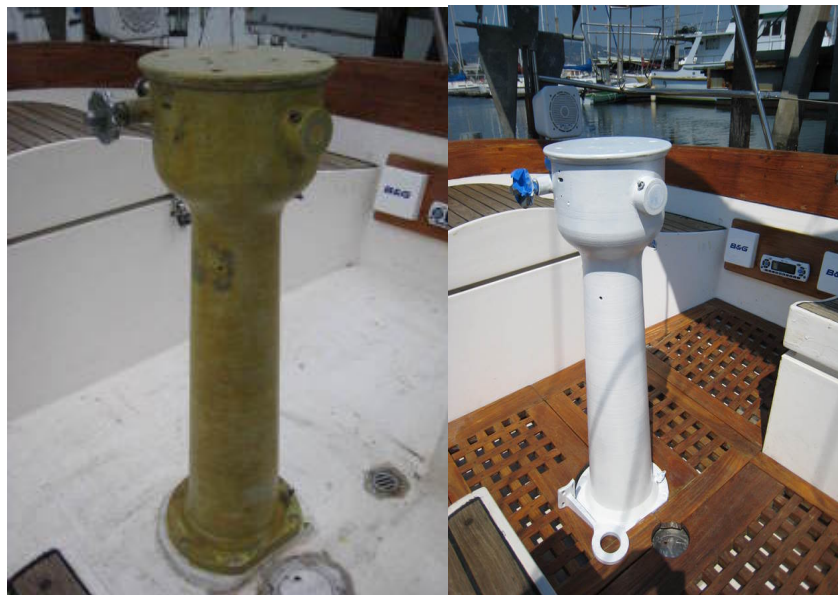
Here is the pedestal after stripping off all the paint, taking it down to bare metal, and priming it with Interlux Viny-Lux Premwash 353.

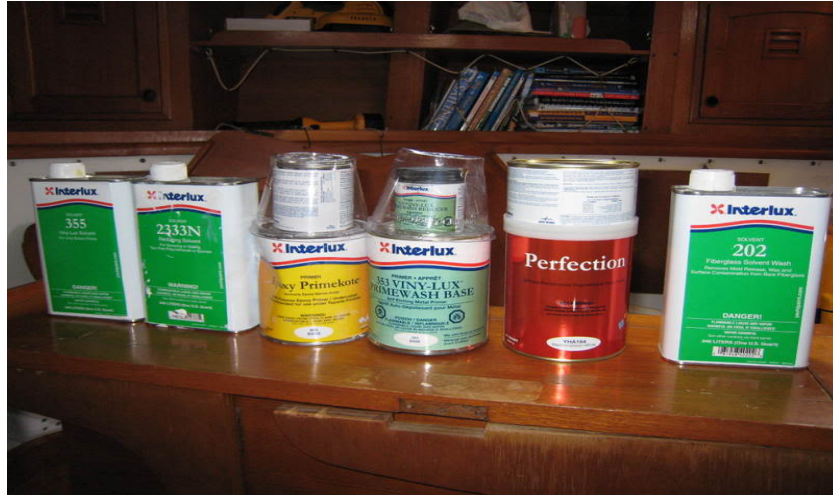
Here she is with her primer coat of Interlux Preimkote 404.

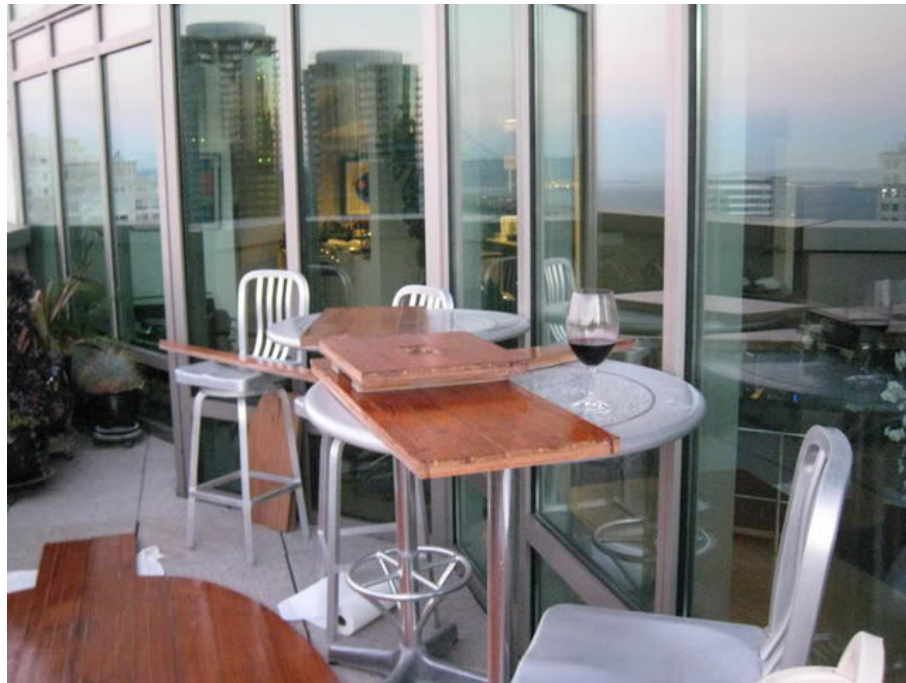
The teak sole is looking good after Bob has stripped, sanded, and sealed it. Here he has the first two coats of varnish (Ultimate Sole).

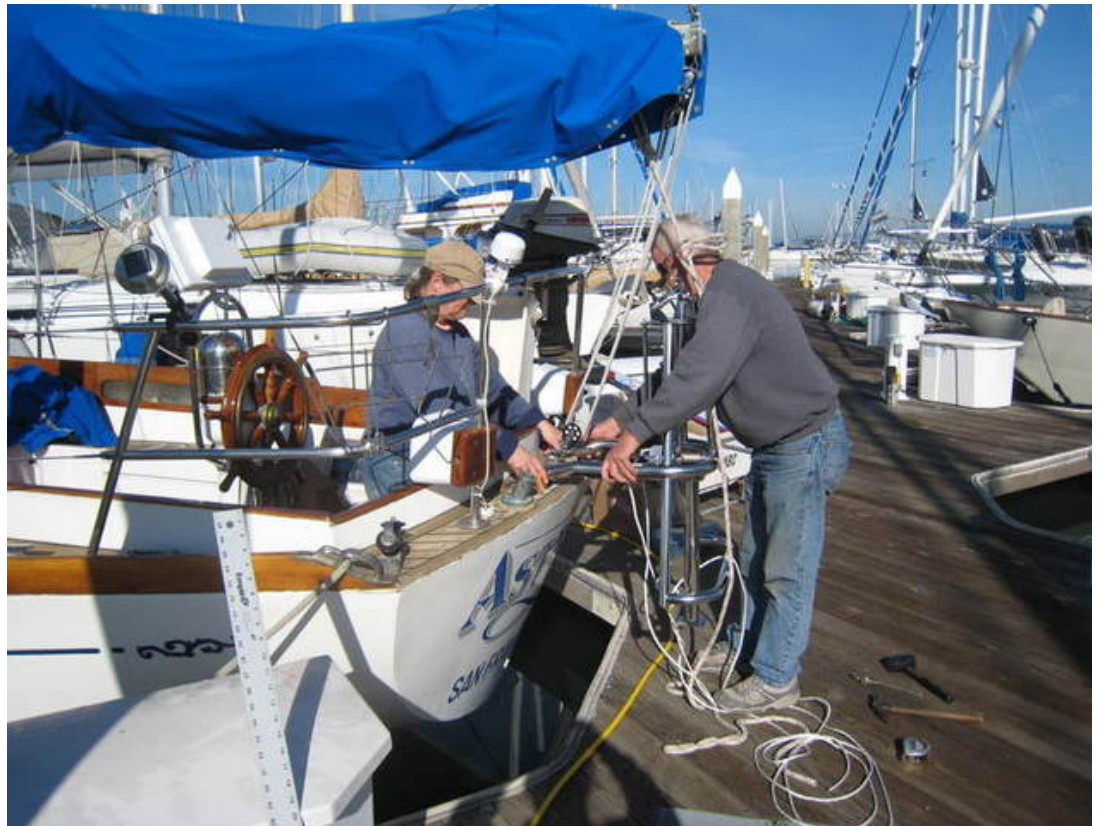
Tim prepares a hoisting line from the mizzen boom to raise the heavy Monitor Wind Vane frame.

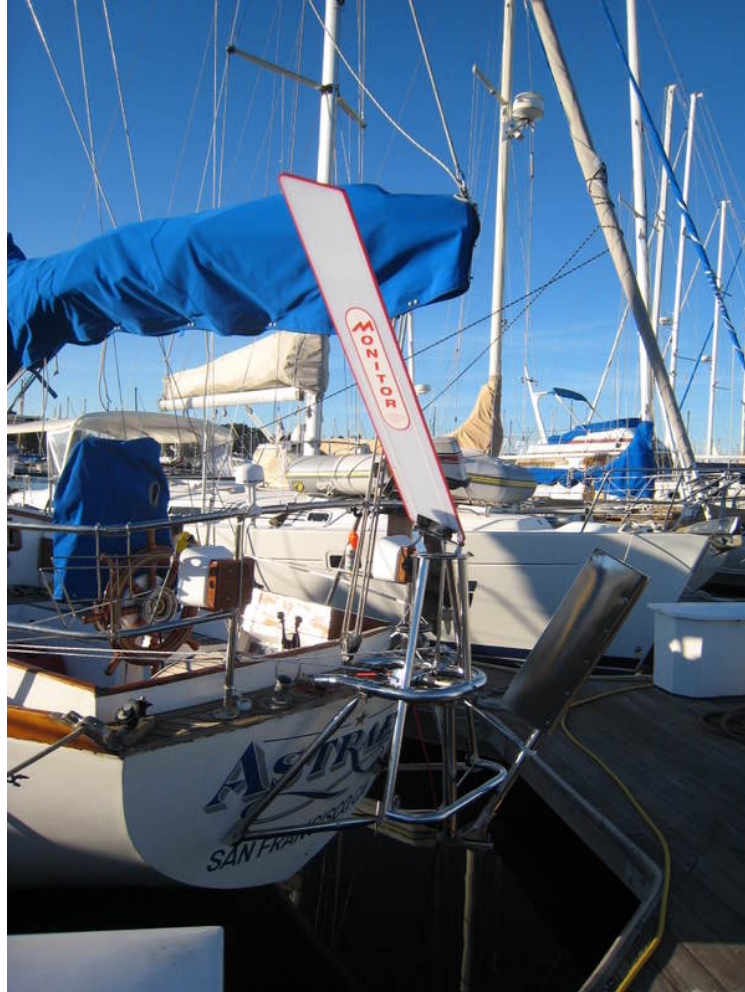
Tim and his partner fit the new wind vane to Astraea's stern. They

commented that the deck and transom were one of the thickest they had seen. They said that this wind vane is so secure that the boat could be lifted by the wind vane. I don't think I will try that, however it is reassuring to hear them say that the boat's structure was so strong.
