THE REFIT OF ASTRAEA

The Refit of a Classic Cheoy Lee 41

Refit Phase IB

Svendsens Boat Works, Alameda, CA

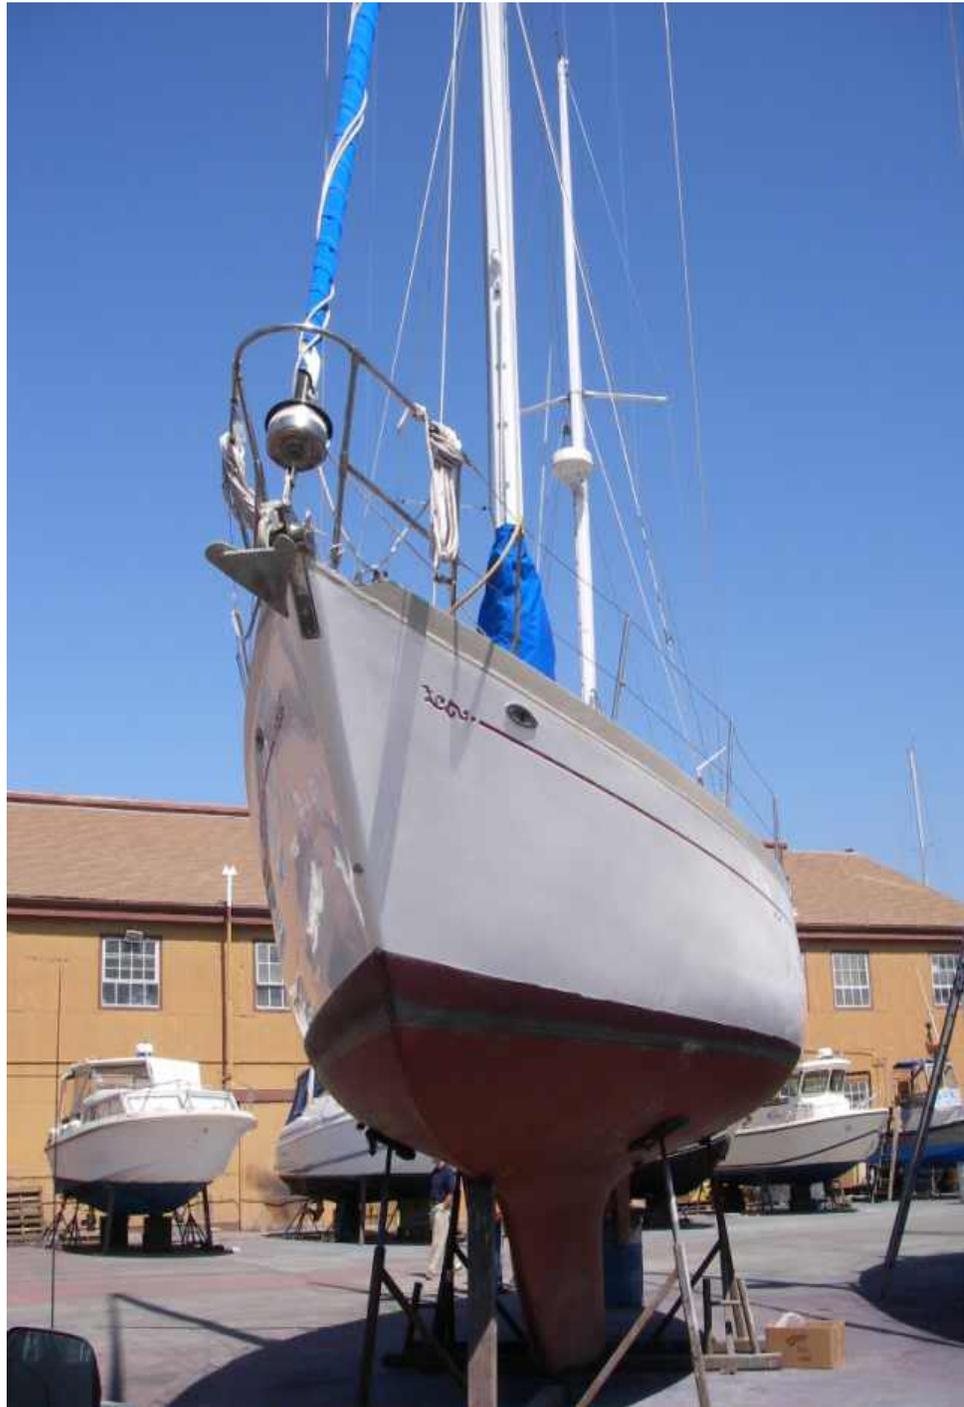
Astraea is ready for her bottom work. Don't you hate this "Rustoleum" red primer look?

While we were at it, I decided that we should paint the bottom. However once she was "on the hard" the boatyard people pointed out that there were so many layers of bottom paint that the paint was cracking. It was time to strip her bottom down to the bare fiberglass and start over with a fresh layer of bottom paint. So, phase 1B began.

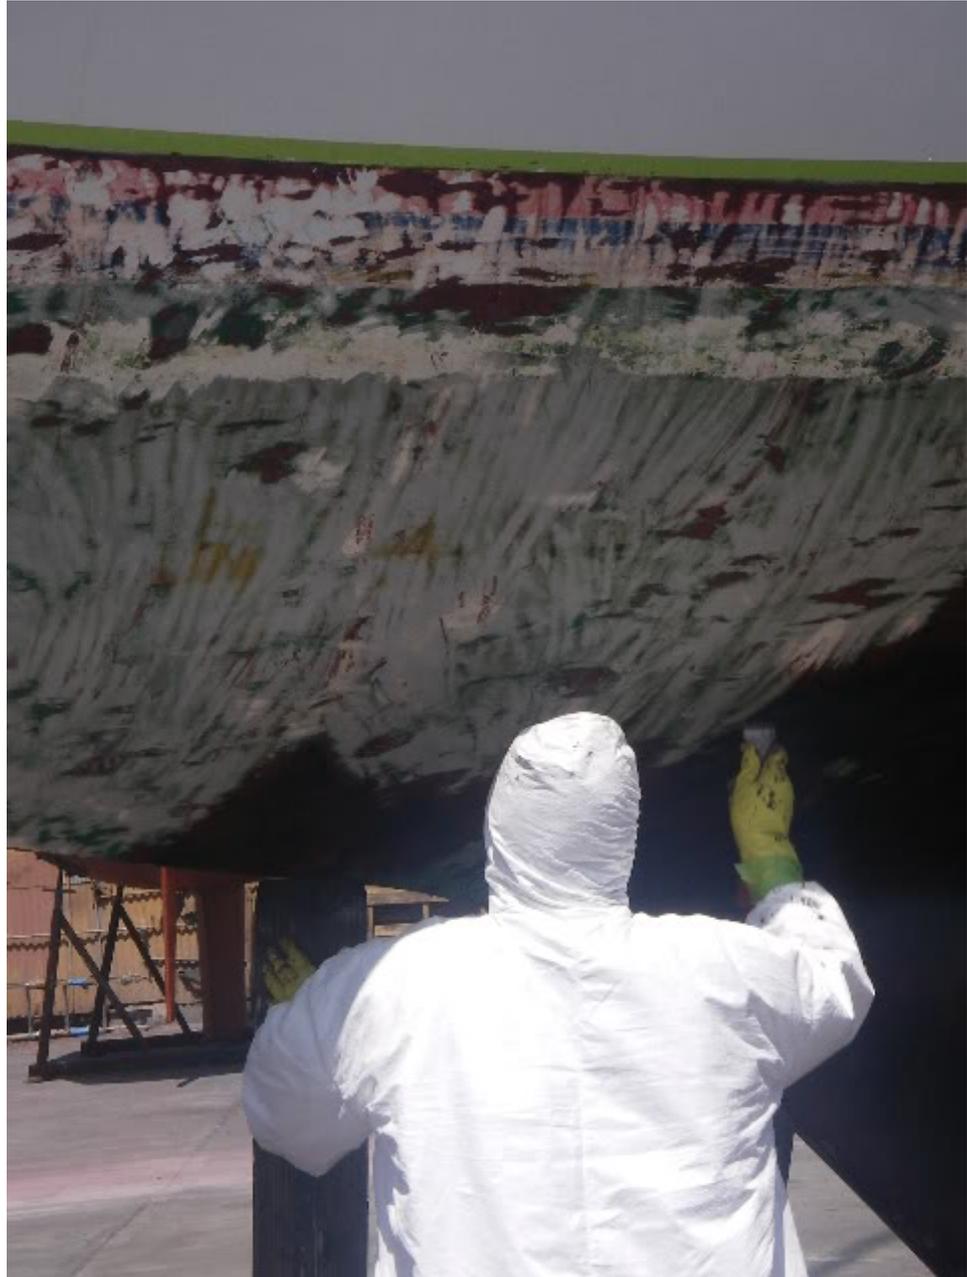
The yard workers in their space suits are applying gallons of stripper and scraping off many, many layers of bottom paint.

As more paint came off it became obvious just how much the waterline had been raised. Also, they had painted over her blue waterline stripe. My immediate reaction was to ask the boatyard to restore the waterline to the original level and repaint the blue stripe at the waterline. However the estimate was an extra \$5,000 to do this. Ouch! The bill for this little visit was already climbing rapidly, so this was not really an option. Oh, well, since this is purely cosmetic it can wait a while. We decided to just go with a bright blue bottom paint to make her look better.

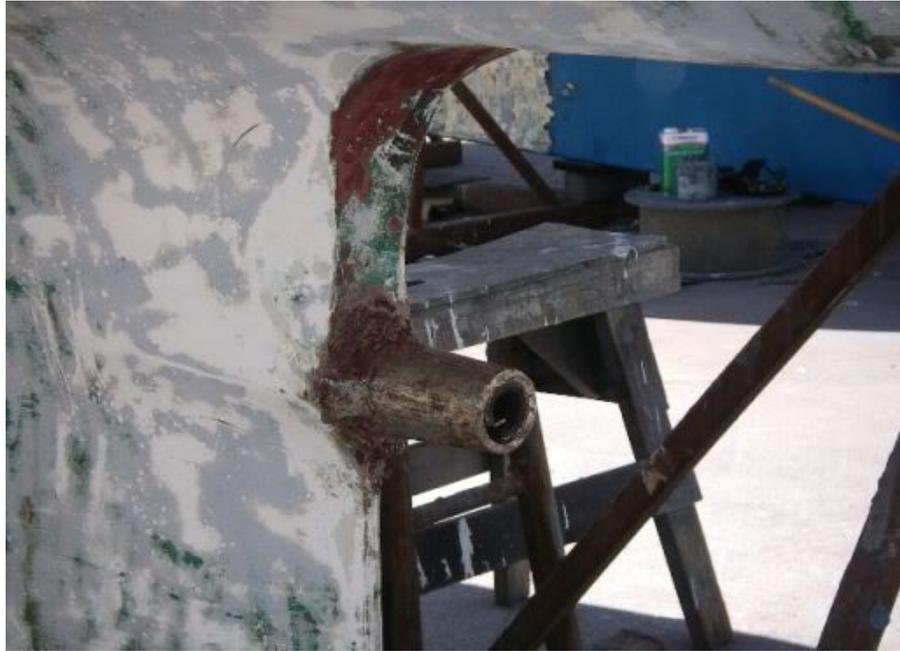
The boatyard removed the old cutlass bearing and will install a new one. As usual, I am pleasantly surprised by the strong construction techniques of Cheoy Lee. This stern tube is really sturdy and well installed. It could definitely take a lot of stress.

Well, the prop is gone. A new one is being made. The new one will hopefully make a difference in performance. While we are at it the yard is also replacing the prop shaft and cutlass bearings. The stuffing tube will be

rebuilt. Interestingly, the boatyard suggested against the new "dripless seals" that I wanted to use and recommended that I stay with the tried and true technology of the original stuffing tube. However they will totally rebuilt the original stuffing tube to make it "like new".

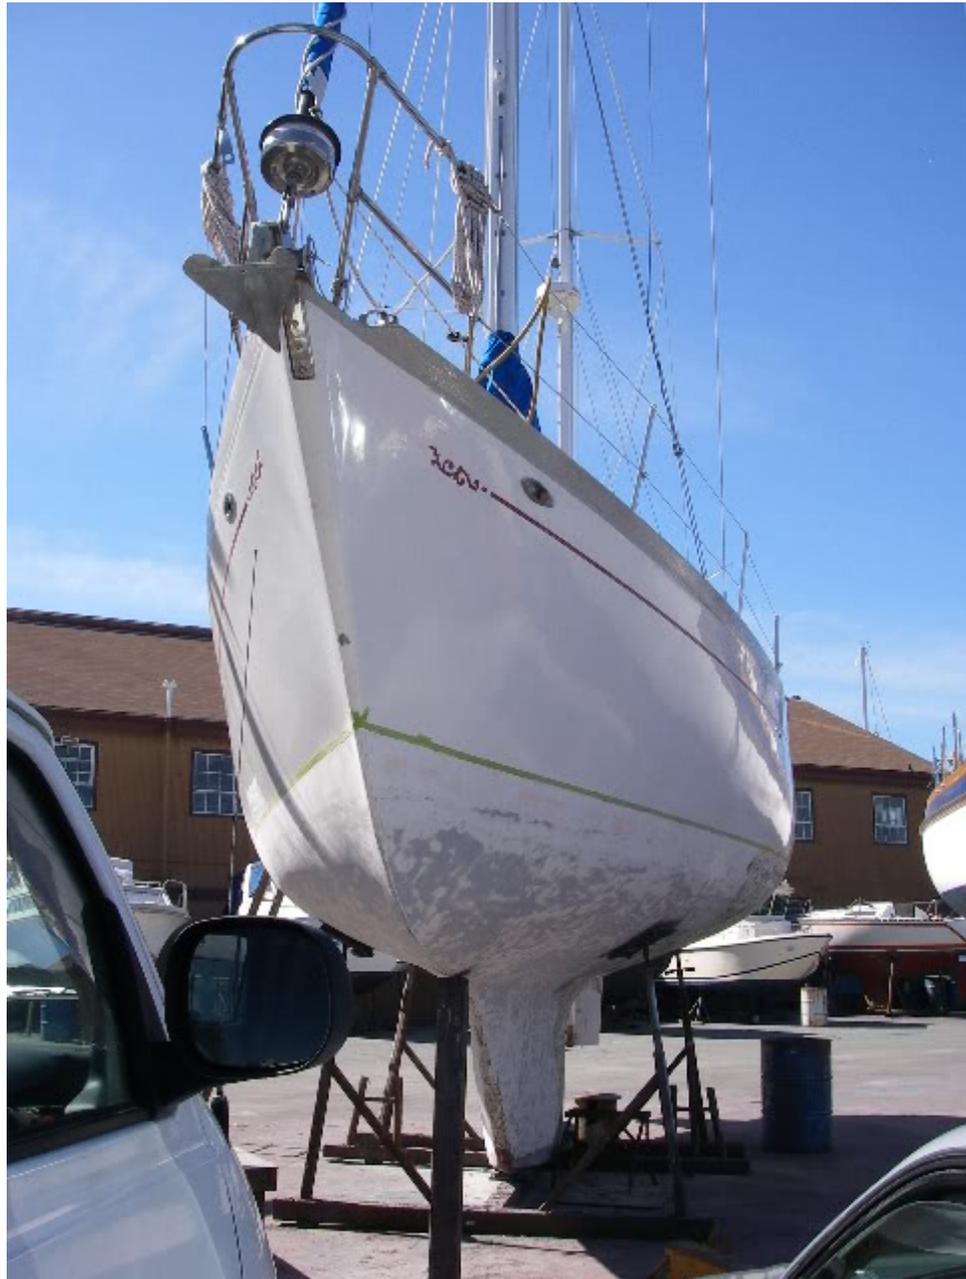
The bottom is almost ready to prime. Lots of old coats of paint removed. Impossible to tell exactly how many, but there were lots of them. There were so many coats of paint that there were deep cracks in the paint layers.

Learning more and more about how she is made. We have removed the old speed wheel and transducer in preparation for the new B&G instruments, and were therefore able to measure the hull thickness in the keel. It is 3/4" of solid fiberglass. Glass and resin and labor was definitely cheaper in Hong Kong in 1981 than it is here in the US today! Above the waterline the hull thins to "only" about 5/8" thickness. Amazing.

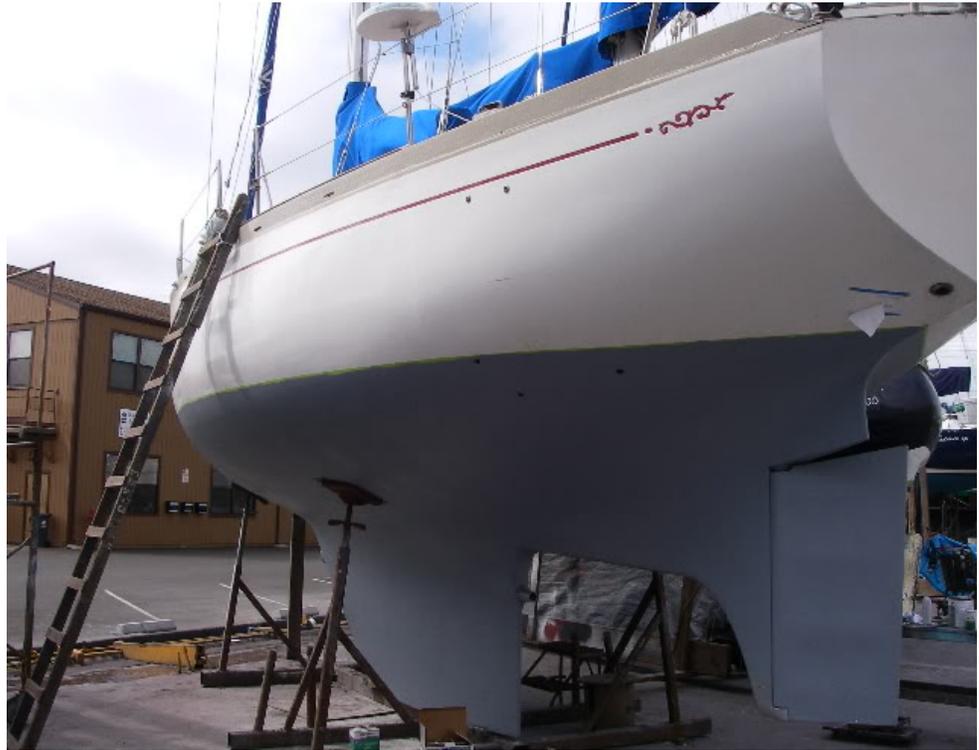
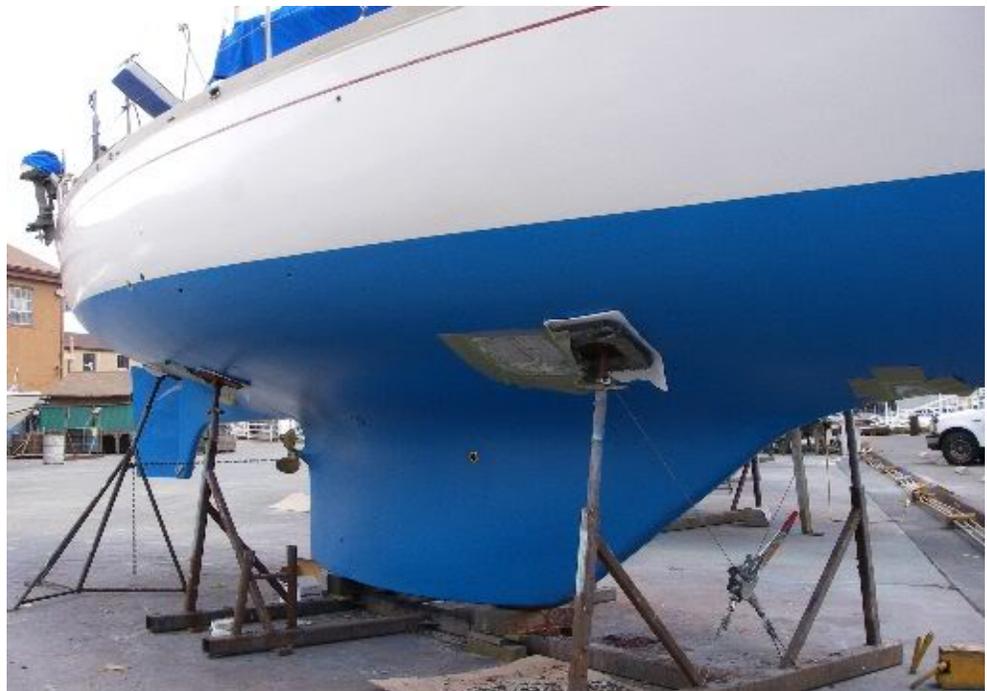
June 13, 2006: Two coats of primer (Interlux Interprotect 2000E) and a couple of coats of Pettit anti-fouling bottom paint in "blue". Yes, it is definitely, "blue". Fortunately no signs of "blisters", a common ailment with some sailboats. It feels so great to just run my hand across her smooth bottom! Beautiful!

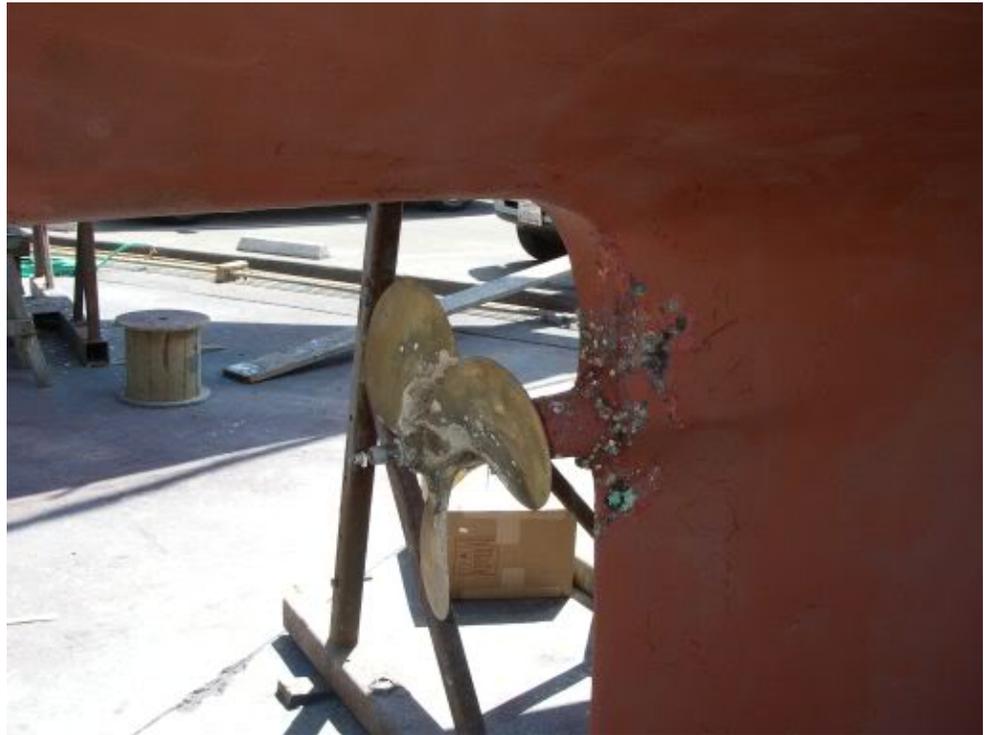
BEFORE (Note you can even see the cracks in the bottom paint).

June 26th, the new prop, new shaft, new cutlass bearing, new zincs, all new! Here is a "before" and an "after" picture. Not only does it look good, the new prop should be a correct size and allow us to run the engine at full RPM to maximize engine efficiency.

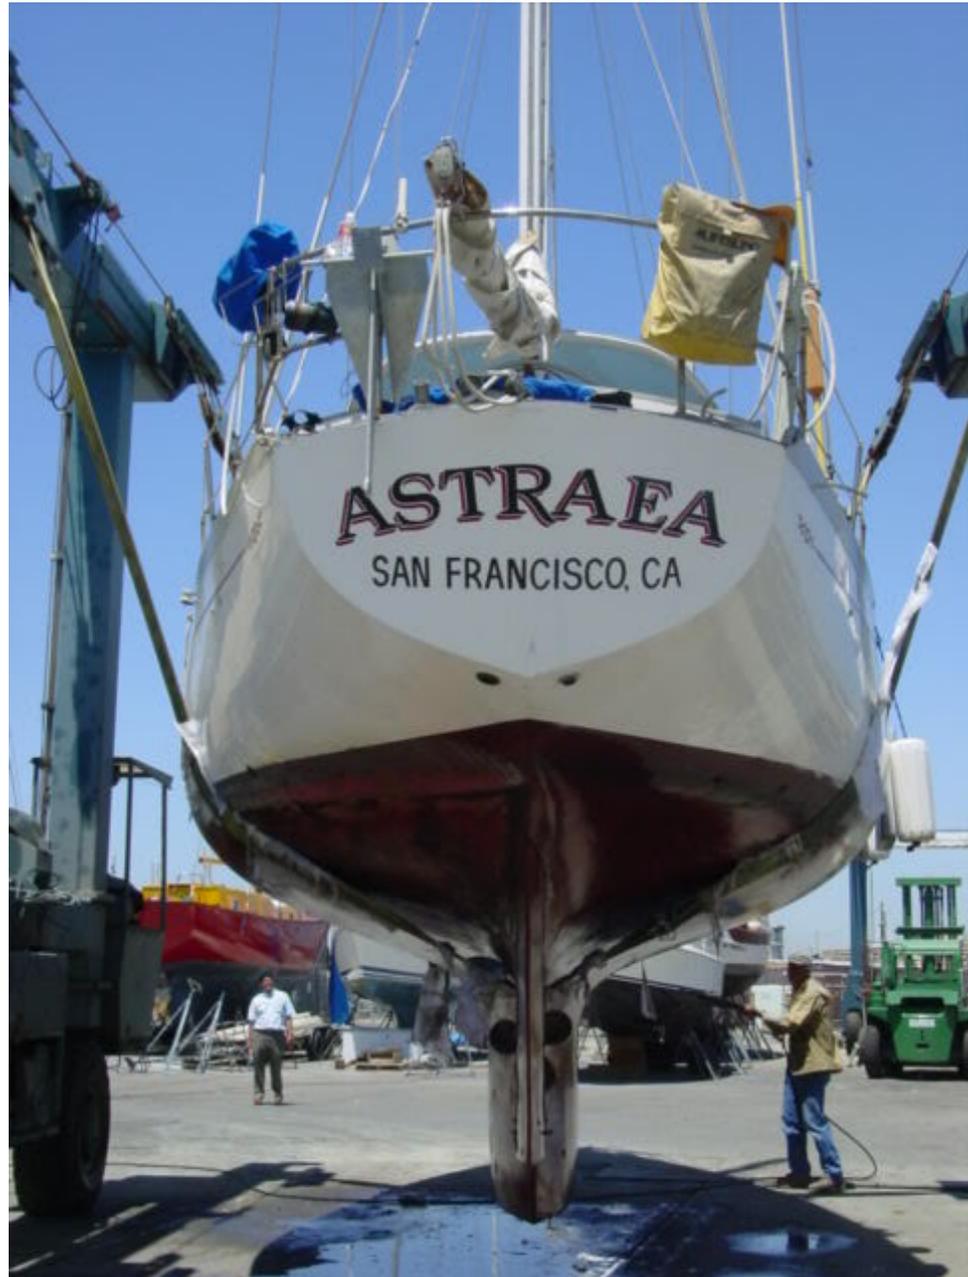
The existing name on the transome dated from her original commissioning and was in pretty bad shape. Here is how her transom looked like when she arrived at the yard:

I spent a weekend day removing the old name, which was painted on. Of course, I made a huge mess out of it. The red paint smeared and soaked into the gelcoat. Oh Oh!

A frantic call to the boatyard on Monday morning. HELP! Once again, the professionals came to the rescue! Svendsen's cleaned up the transom and made it look great. A clean, smooth, fresh palette ready for the transom painter to work on!

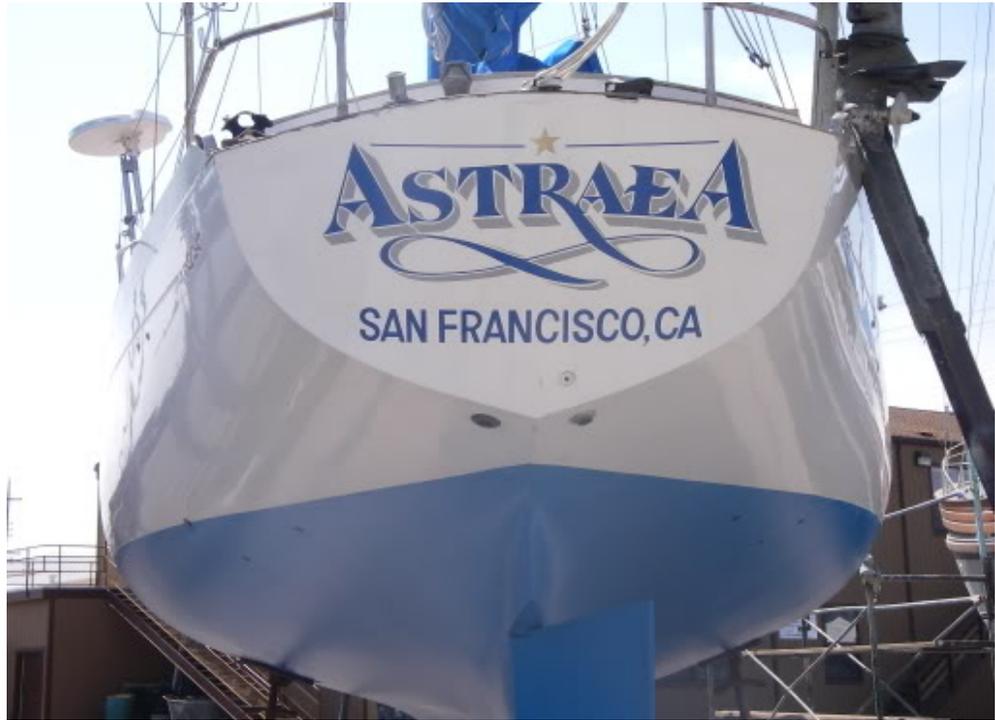
Here is what she looked like after George Kelly did his art! Awesome! If you want to contact George, he is true professional!

George Kelly designed a new format for the original name (still *Astraea*, of course, as we like the name and also do NOT want to upset the Gods!).
