THE REFIT OF ASTRAEA

The Refit of a Classic Cheoy Lee 41

Refit Phase III

Svendsen's Boat Works, Alameda, CA June 25, 2008 - September 23, 2008

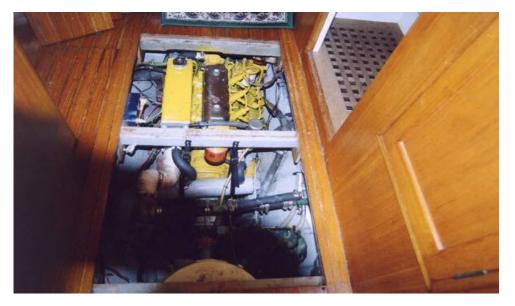
The REPOWERING Project. Here is Astraea with her original Isuzu QD-40. Good old faithful engine, but being three cylinders she was never very well balanced and had a lot of problems with engine mounts and anything attached to the engine. Also, she was 1981 vintage and hard to find parts for.

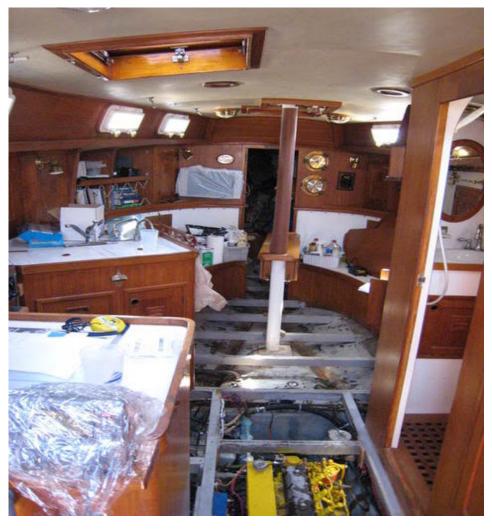
Here the cabin sole has been removed to provide access to the entire bilge area. The yards will be removing the Isuzu and replacing it with the new Westerbeke 44 and new transmission. This will also allow the electrician to more easily run some new wiring and install the the Furuno Navnet2 Network.

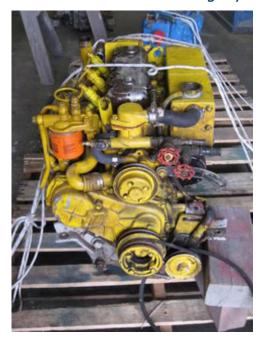
My old faithful Isuzu sits in the shop ready to go to someone else. She has found a good home as one of the boat yard riggers is going to adopt her for his boat. I am sure he will get years of good use out of her.

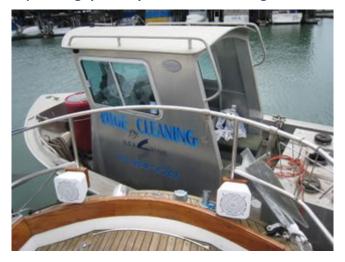
This time the engine is gone and all the deck sole is removed, so Astraea is getting a deep cleaning of all her bilges. The bilges will then be ready for repainting (white!) and the new engine.

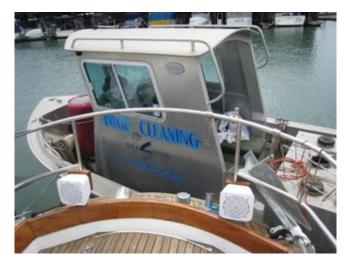
The bilges are a mess. Some 25 years of grease and dirt were under the engine and will now be professionally cleaned out and repainted. Here she is with the bilge cleaning in progress.

Rod Kux of seashine hard at work at the very dirty job of cleaning the greasy and oily bilges and, of course, disposing of the oil waste properly.

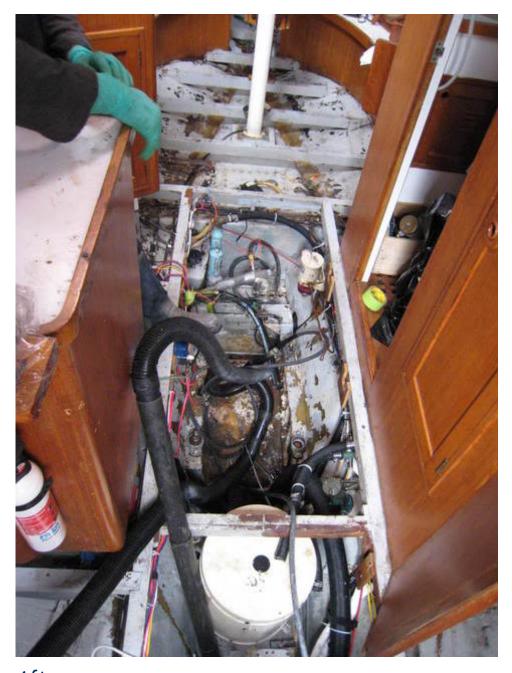
Before:

BEFORE AND AFTER. Everyone likes before and after pictures. Here are the bilges before SeaShine cleaned them and the yard painted them, and then a picture of the "after" cleaning and painting. Quite a difference!!!

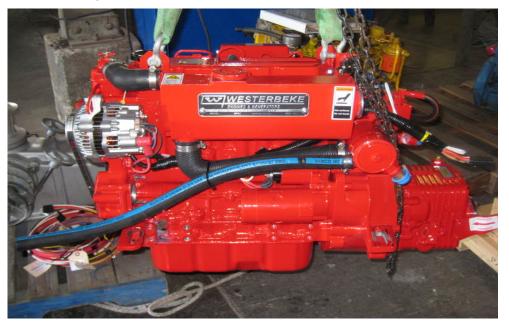
The new Westerbeke is finally out of the box and is being modified with dual pulleys in order to handle a larger alternator and the reefer compressor.

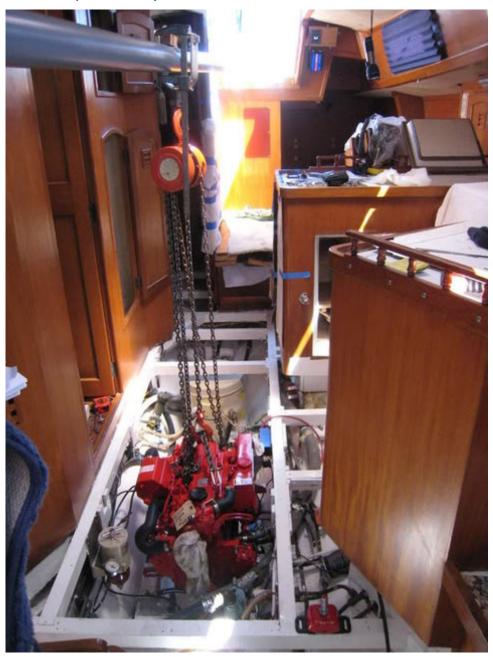
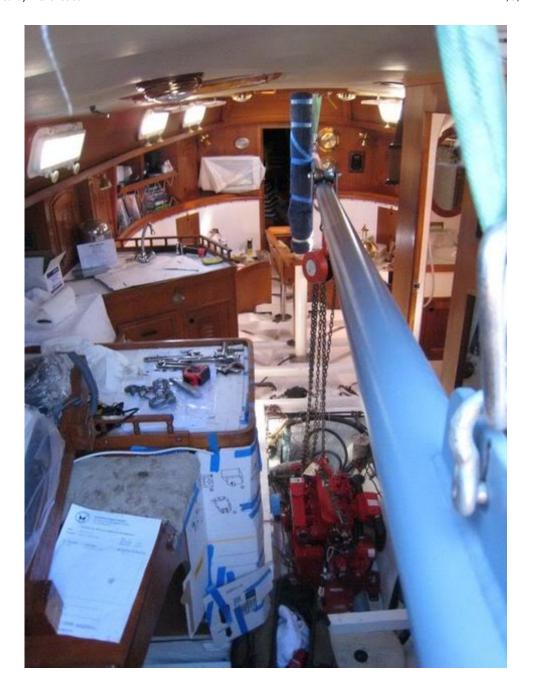
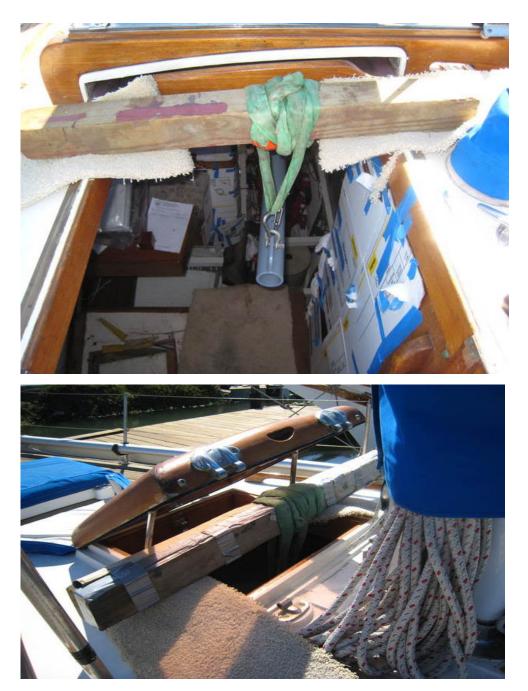
Here is the rigging as the new Westerbeke is rigged and put into place. Quite a complex procedure to get it into place. Note how

they suspended the pipe from crossbeams at the forward hatch and companionway. $\,$

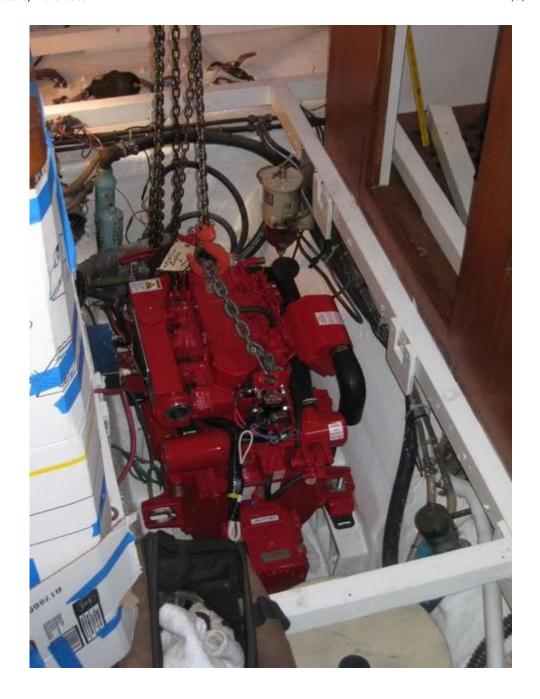
Here she is sitting on the new engine base, ready to be installed.

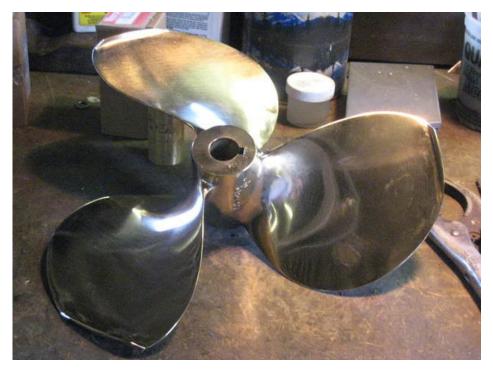
Here is the prop, now a 14x10, previously 14x12. Note the feathering of the prop blade edges. This is some new technique which is supposed to make the blade more responsive. Interesting, I have never heard of this before.

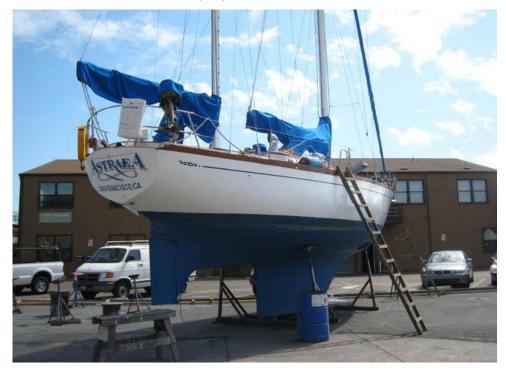
Astraea waits for her new prop.

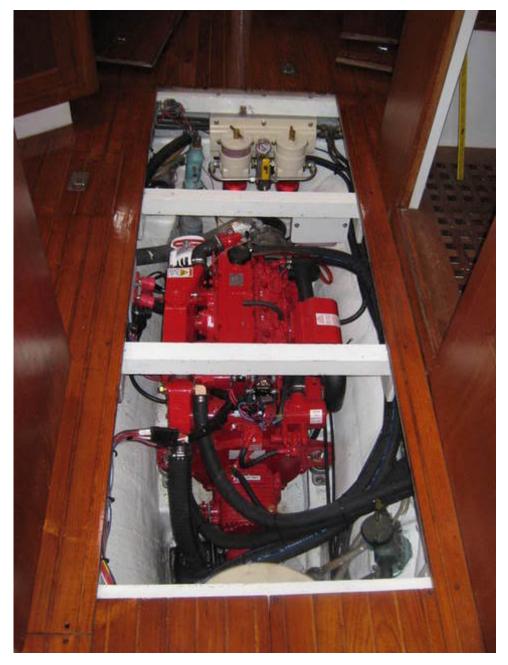
Friday, September 12th, 2008. Finally, finally, finally the new engine is fully installed. Scott, the diesel mechanic and I took her out on Friday after lunch and did a sea trial in the Alameda Estuary and it was sweet! Smooth, no vibration, all went perfectly. Only problem is that she cannot get over 2700 RPM and we need to get 3000, so it will be necessary to repitch the prop by an inch or so. Engine looks great! Catch the new dual Racor fuel filter. Sweet!
