THE REFIT OF ASTRAEA

The Refit of a Classic Cheoy Lee 41

Restoration and Re-Fit Phase IB Continues

Work continues into July 06

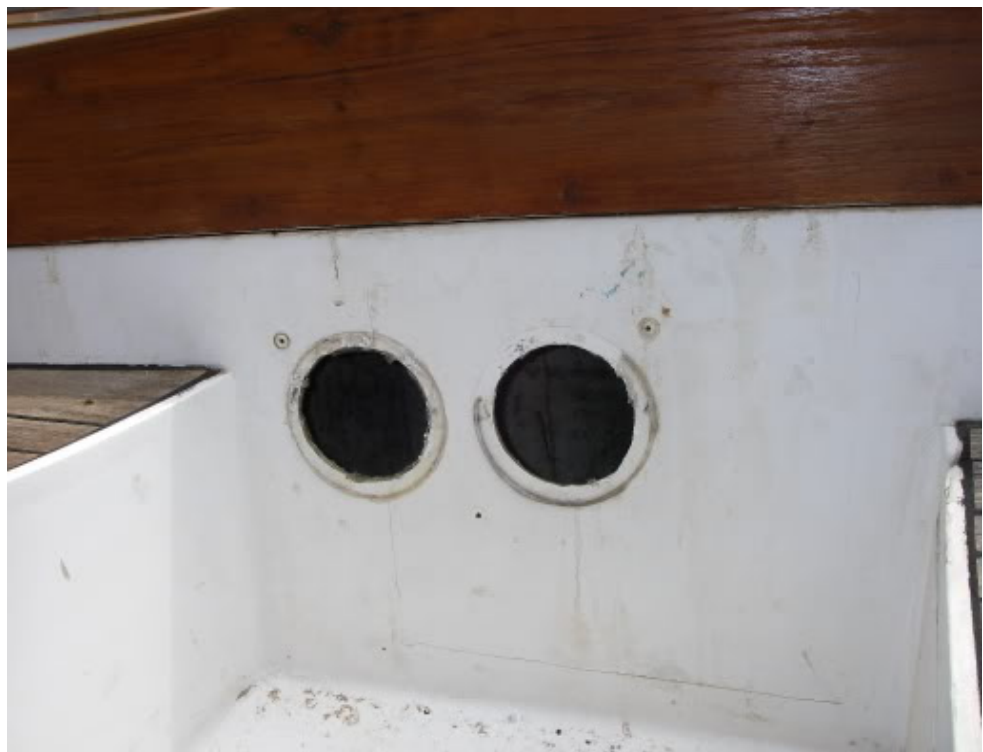
Here the old gauges have been removed. Watch this space for the fabulous new installation of B&G we are doing! (I say "we", it is really "they"). The old Datamarine were original to 1983 fitting out. Time to replace them.

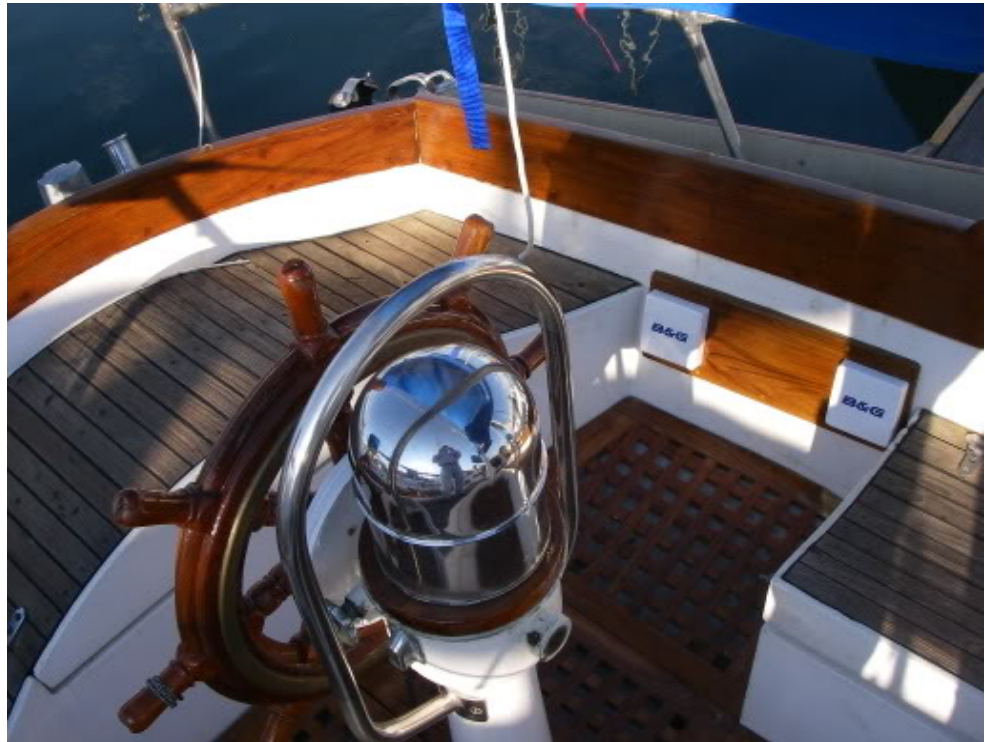
Here is what she looks like after the new B&G instruments were installed this past week! Looking good!!!!

However other things are happening! The old B&G depth and speed instruments are being installed to replace the old Datamarine instruments that had been installed in 1987.

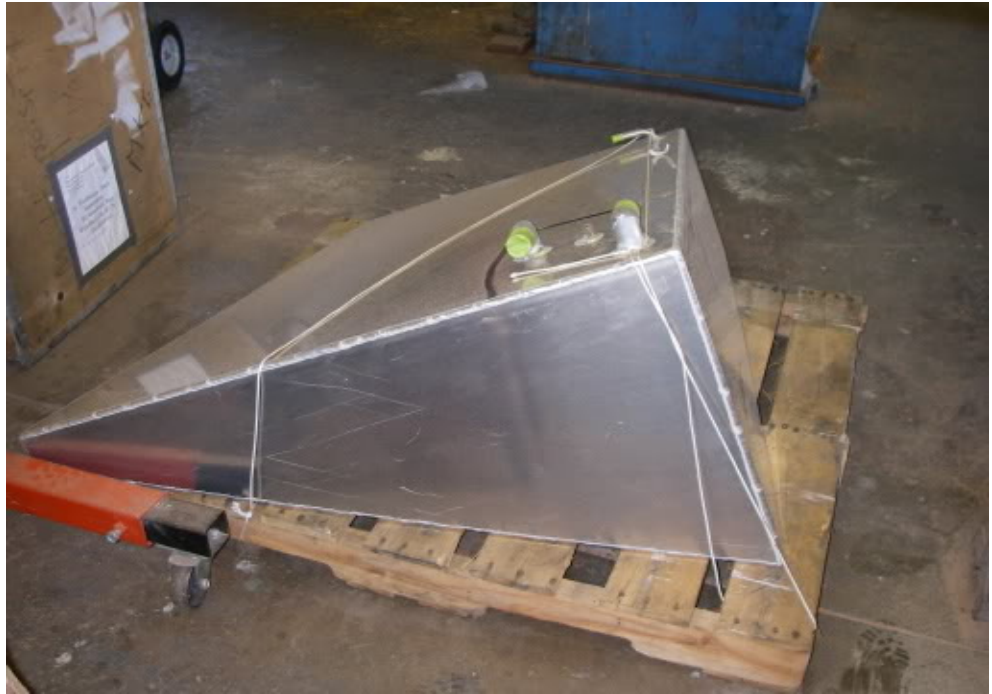
Here are pictures of this new "work of art" known as the holding tank. It is a shame it will be hidden under a bunk.

July 25, 2006: Remember that fancy new holding tank that I had some doubts would fit through the companionway access? Of course Adam had said, "Of course it will fit! We measured!". Yeah, sure. Turns out that I WAS RIGHT! It will NOT fit through the companionway hatch! So the tank is now back in the metal shop being cut back to a size that they can get into the boat. Gheeze! 🤢

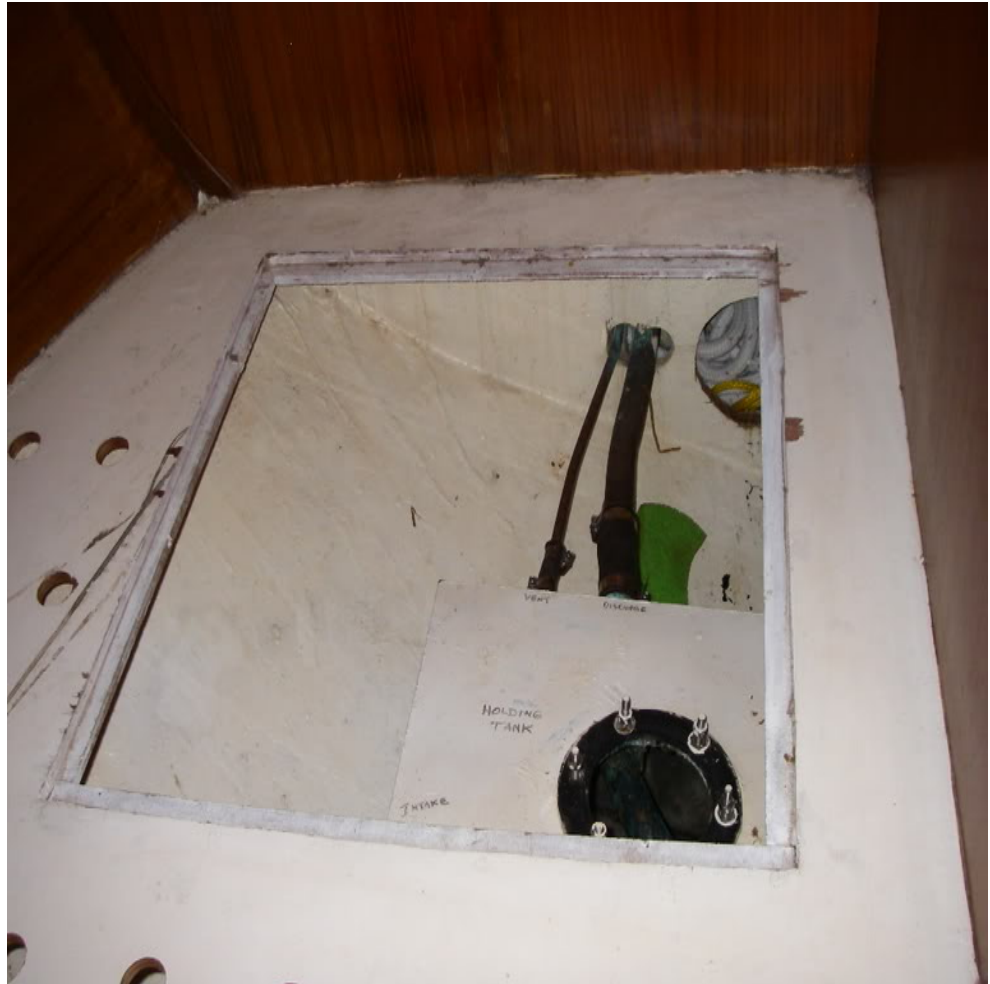
Here is the old holding tank, small 20 gallons.

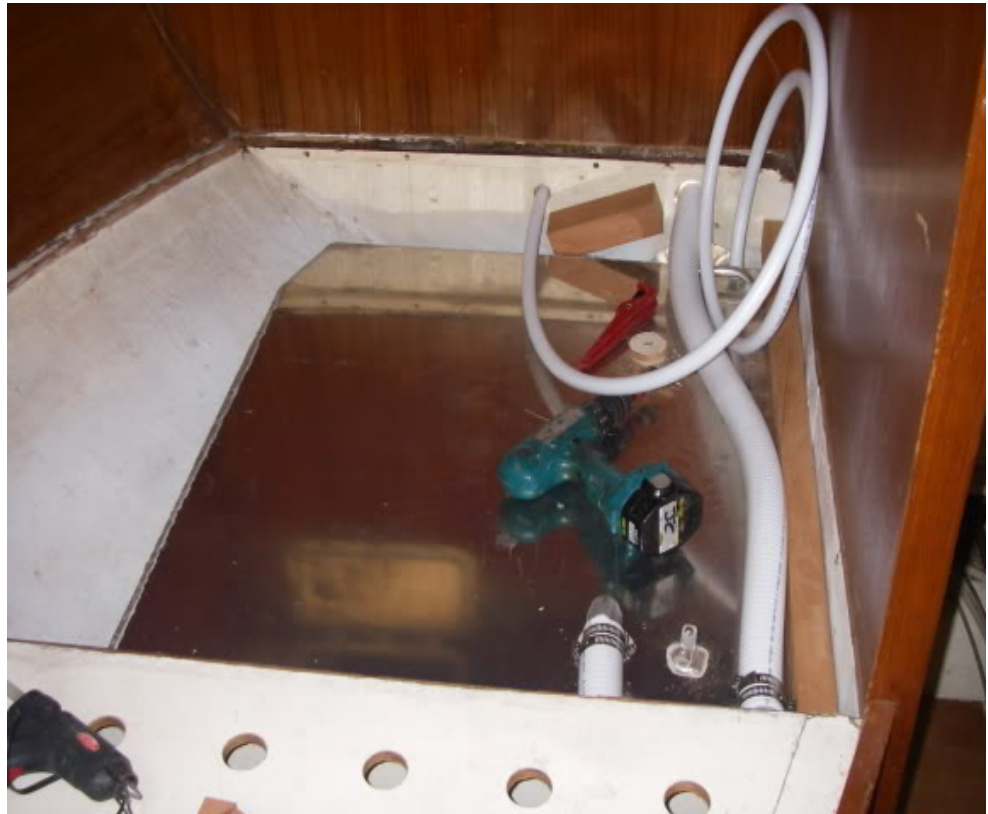
Here is the fancy new one! Not sure how large it is, but it is certainly MUCH larger than the old one!

morning. Last step, they got the holding tank in! As you can see it is MUCH bigger than the old one.
