THE REFIT OF ASTRAEA

The Refit of a Classic Cheoy Lee 41

November 2007 - February 2008

Phase II: Electrica
System Update, New
Force 10 Stove,
Bottom Rework Part
Deux

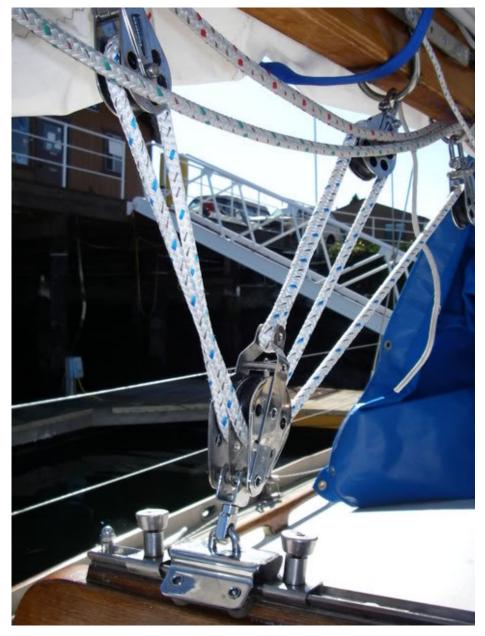
Another rigging job was the repair of the main sheet track and installation of a new main sheet traveler. When I was visiting the Cheoy Lee offices in Hong Kong recently and taking a tour of the old sailboat parts warehouse I found a brand new traveler to fit our boat. Ours had been broken during a most unfortunately accidental jibe back when we were first learning how to sail her. However, one of the hold down bolts to the track had also broken and the track was deforming. This meant removing the MANY hold down bolts and repairing and reinstalling the main sheet traveler track. While we were at it we went ahead and had a new main sheet (line) made and replaced the three blocks on the boom. The new installation is SWEET! Now we just have to make sure and use a preventer and not do any more hard accidental

Looks great, huh? You know, this is a CRUISING boat, not a racer. This works just fine.

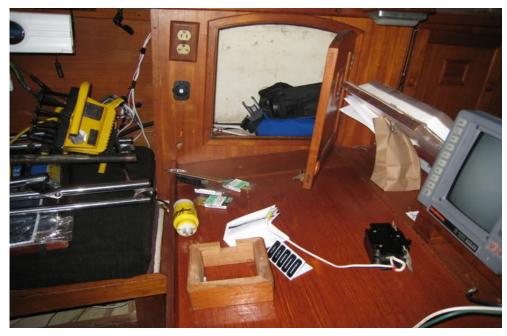
In progress. Excuse the mess. She is in the yards!

The wiring behind the electrical distribution panel was a total mess! Too many things had been added. The ABYC certified electrician cleaned it all out, corrected the wiring, removed old dead wires, put in a new main power switch, and a new shore power circuit breaker. The new circuit breaker is up near where the shore power enters the boat. He also installed a galvanic isolator for defense against stray voltages from boats whose electrical sytems are not correctly installed.

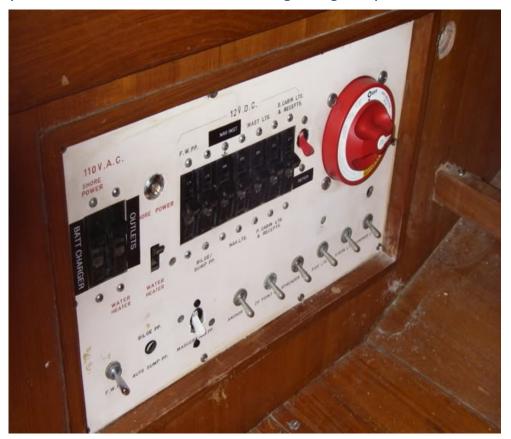
New and improved electrical panel! Totally rewired and rebuilt.

Exzcuse the dust in the picture, the poor boat has been in the yards for over two months and is getting dirty!

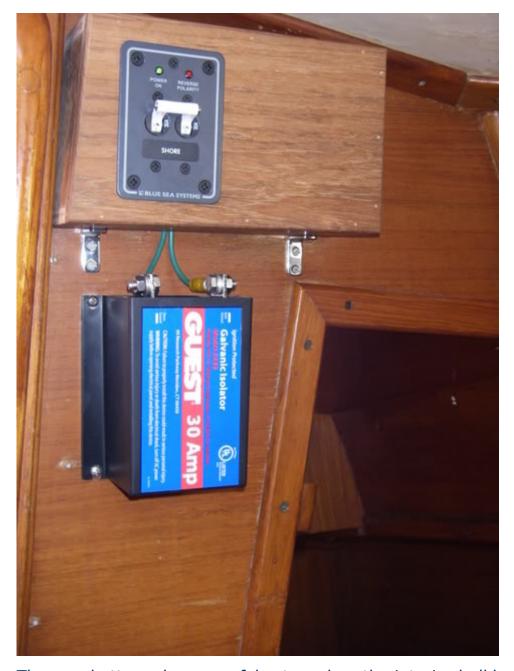
New main power breaker and galvanic isolator. I am going to have to make a teak box to cover that galvanic isolator. That is UGLY. Another job for the woodworkers in Mexico!

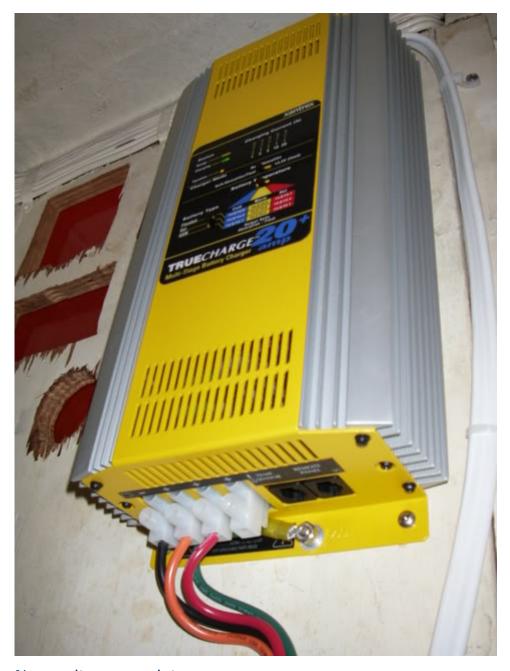
The new battery charger safely stowed on the interior bulkhead of a hanging locker in the stateroom. Safely shielded from water and damage.

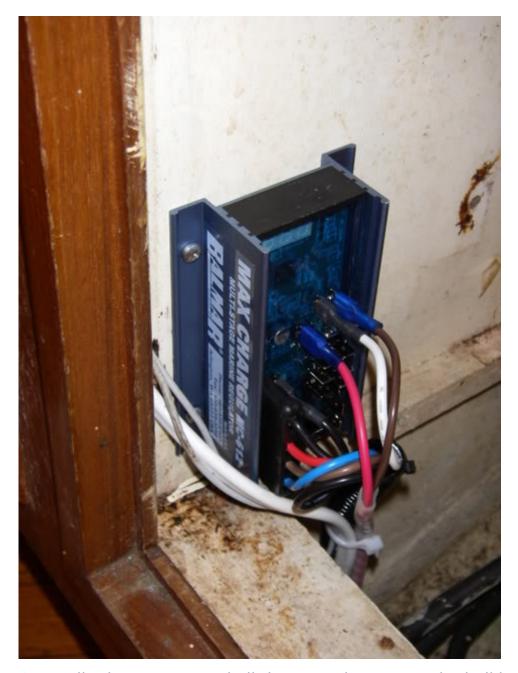
New voltage regulator.

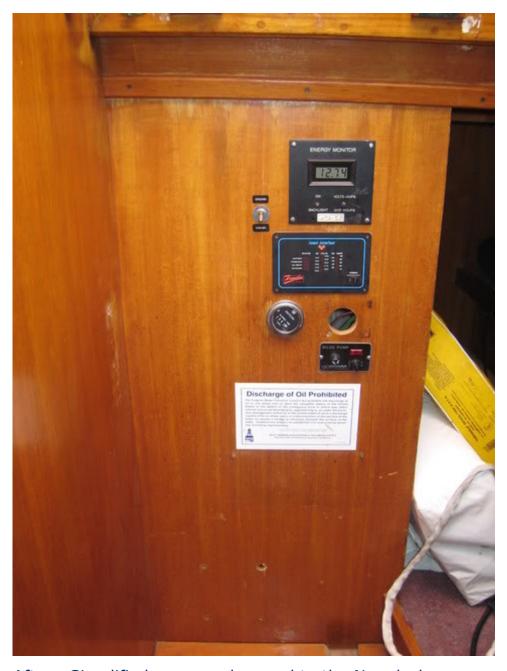
Before:

Originally the inverter and all the controls were on the bulkhead behind the ladder from the cockpit to the interior of the boat. Not really a good idea were a wave of water to crashing in.

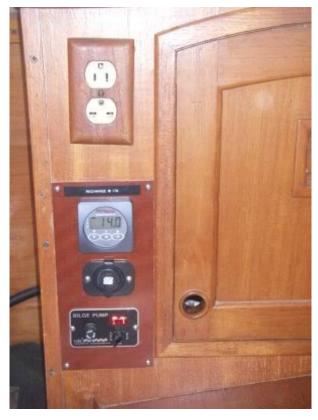
After. Simplified, new, and moved to the Nav desk.

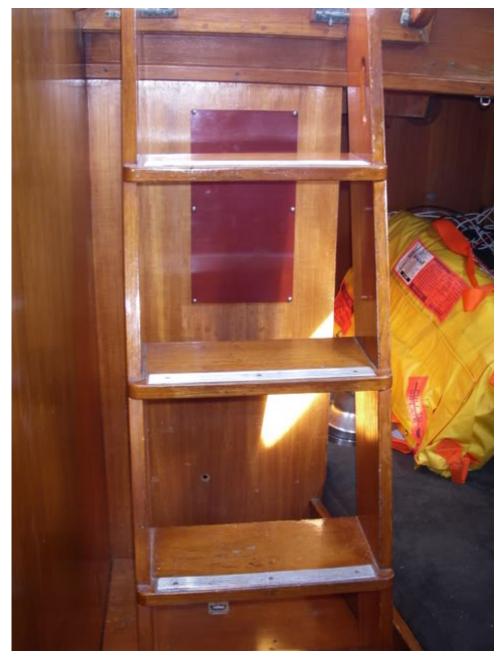
After:

The new battery charger is safely inside a hanging locker, protected from the elements. All these instruments were removed. The yard covered the old holes with a piece of bakelite type material. I will have it properly patched and repaired later when we are in Mexico.

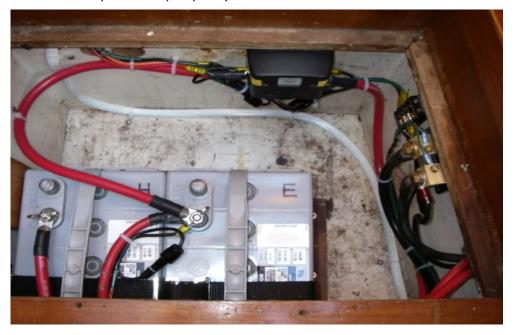
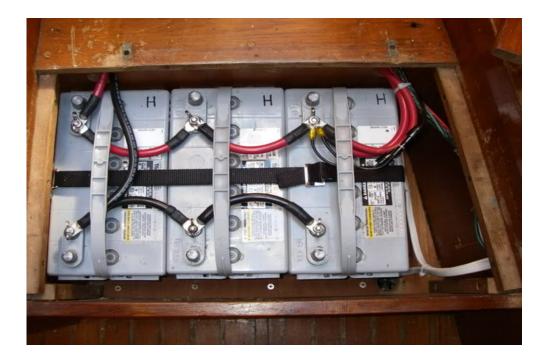
Under the accomodation ladder are the five gel cells (4 house and 1 starting). This space was a rats nest of wires and old electrical components. There are now five new gels, the gels are properly secured from moving, and every component, fuze, and wire was replaced. Sweet! Really, really nice work.

Before. Old cracking wires, old fusing, lots of dead wires:

After: All new components and an automatic cross-over switch for charging, new fuses, new wires, even the batteries are new. And all simple and properly installed. Sweet Sweet!

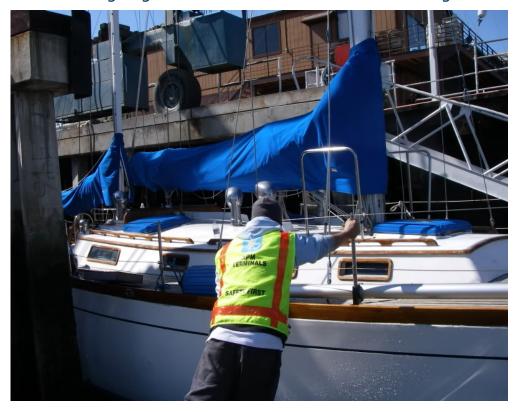
Sitting at the dock for so long at the boatyard Astraea's bottom was looking a little fouled. It had been 18 months since her bottom was totally redone, and I had hoped it would last longer, however apparently the Interlux VIVID does not work that well with soft slime growth in San Francisco.

Here she is going into the travel-lift at Svendsens. Again.

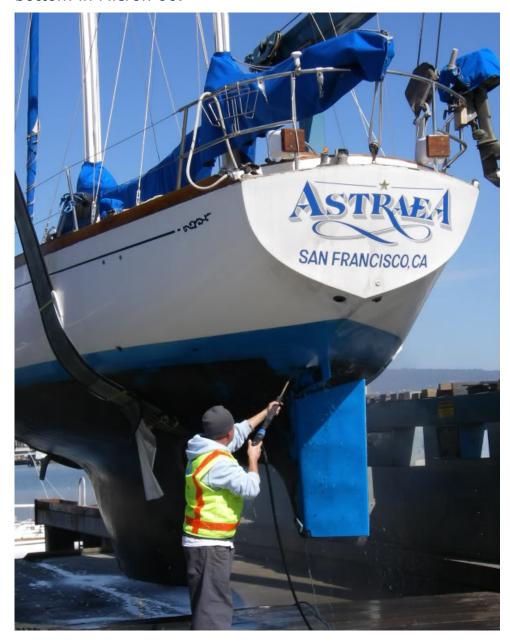
After a power washing the slime came off and the bottom looked perfect. However I decided that I needed to try a new paint, Interlux Micron66, which is not supposed to slime. So had the yards snd off the "old" new paint, the VIVID, and repaint the bottom in Micron 66.

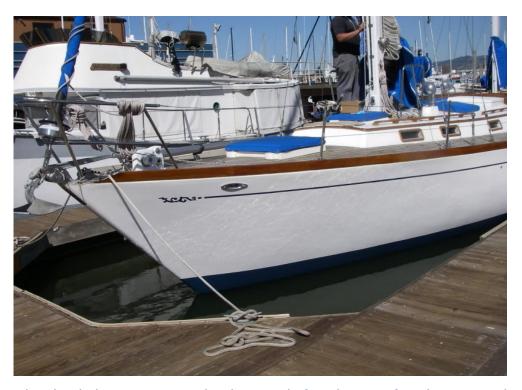
This time went with a dark blue instead of the light Pacific Blue. Also had just had the coving stripe painted by George Kelley in the dark blue. Unfortunately they splashed her before I could get a picture of her out of the water with her new dark blue bottom. However here she is with her new color scheme. Awesome!!!!

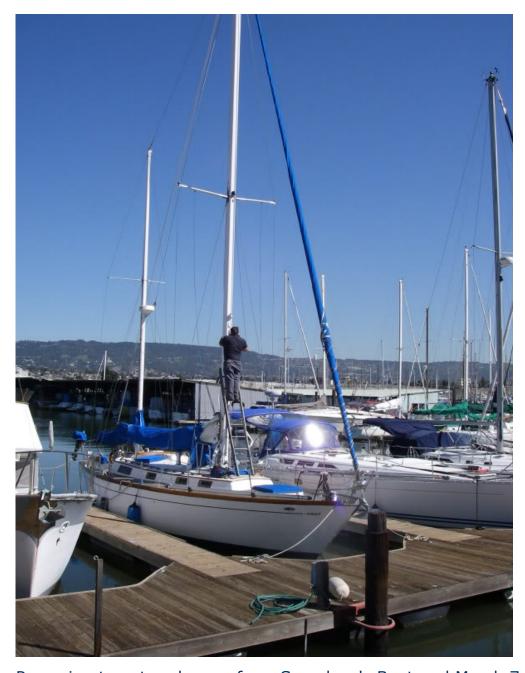
Also had the riggers redo the track for the car for the new whisker pole. Kept the original Cheoy Lee track, but they rebuilt the car to handle the new whisker pole and rigged it for up and down movement. Can't wait to try it all out!
