THE REFIT OF ASTRAEA

The Refit of a Classic Cheoy Lee 41

Refit Phase IB

Svendsens Boat Works, Alameda, CA

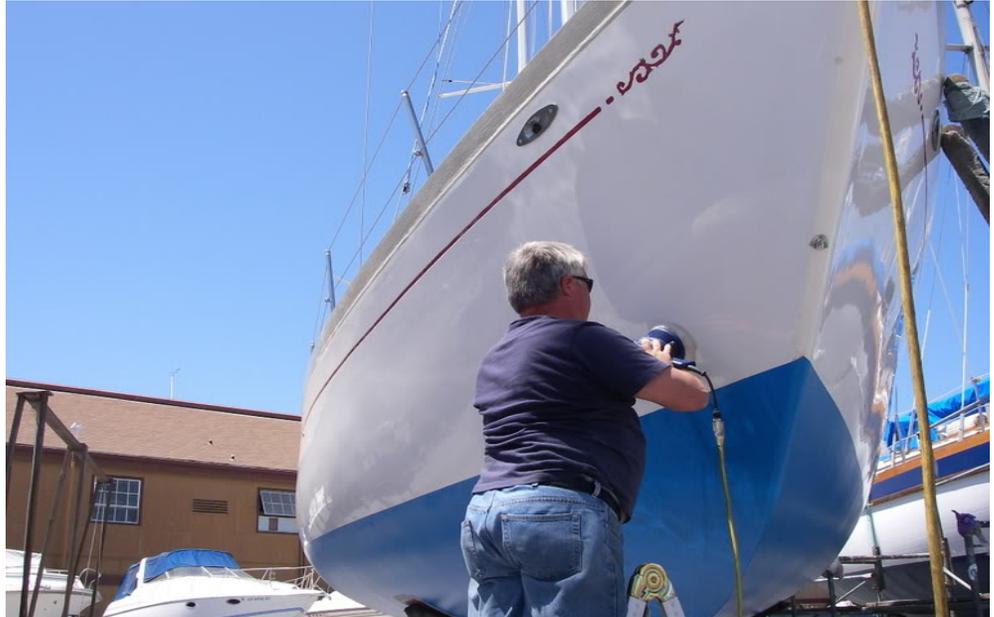
June 18, 2006. Spent a good part of Sunday waxing Astraea in preparation for her going back into the water next week (we hope!). Here is Bob up on the ladder buffing her up after we applied a coat of hard boat wax.

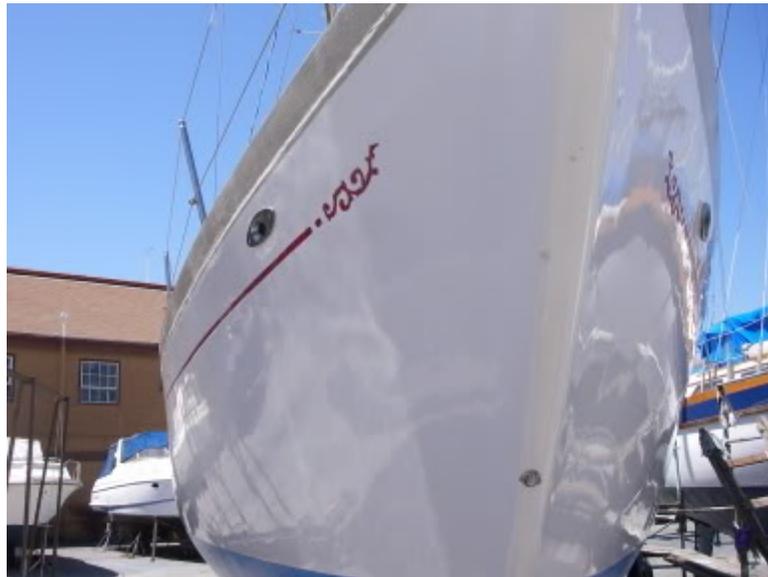
Here she is. Looking good!!!! (At least until I smash her into the dock the next time)
