THE REFIT OF ASTRAEA

The Refit of a Classic Cheoy Lee 41

Phase III Continued

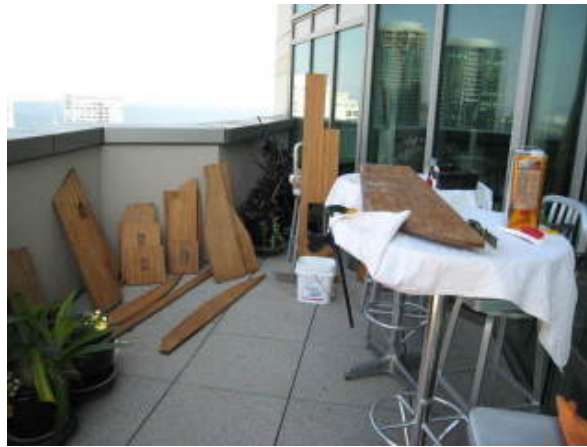
In the meantime, on the homefront, Bob has been working to strip several hundred square feet of teak and holly sole. Unlike modern production boats, the cabin sole on *Astraea* is half inch solid teak with holly strips inlaid a quarter inch deep. The half incho of teak is then glued to a half inch of hard marine plywood, making these sections of sole an inch thick. They are also heavy! The stringers that hold these sections of deck sole are 3x3 solid teak beams. This really provides good lateral strength to the hull and also provides a lot of weight down low in the boat. Another reason that this class of sailboat has been called "stiff as a church".

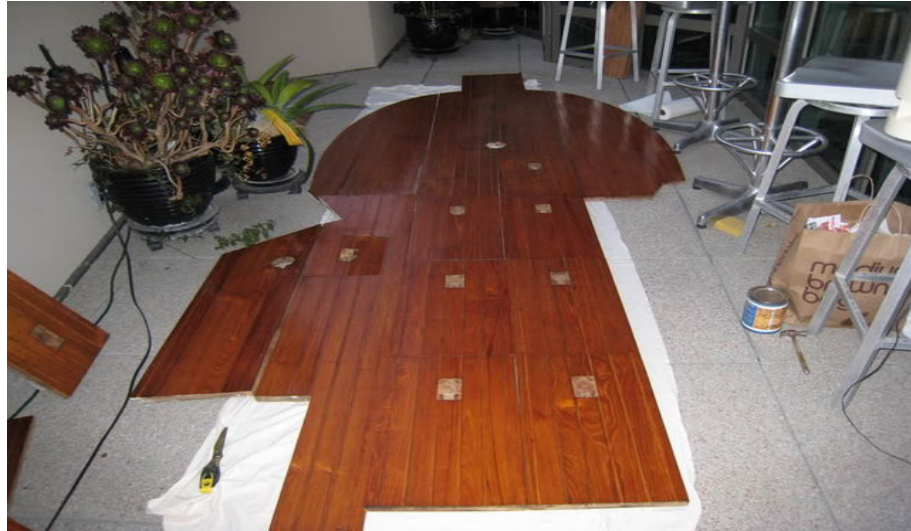
The teak sole is looking good after Bob has stripped, sanded, and sealed it. Here he has the first two coats of varnish (Ultimate Sole).
